Table of Contents

Fort Monroe	Mothball Project	2011
4.3.2: Cast Iron (Brief 27)		27
4.3.3: Rust on Metal Roofing:		28
4.4: Roofs		28
4.4.1: Wood Shingles (Brief 19)		28
4.4.2: Asphalt Shingles		29
4.4.3: Slate Shingles (Brief 29)		29
4.4.4: Built Up Roofing System		30
4.4.5: Flashing		30
4.5: Lead Base Paint and Asbestos		31
4.5.1: Previous work		31
4.5.2: Regulations		31
4.5.3: Lead Base Paint		32
4.5.4: Asbestos		33

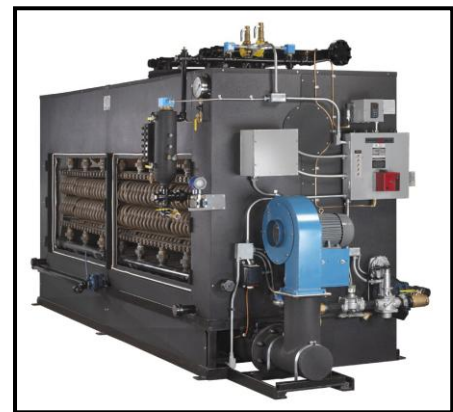
Figure 4: Hot Water Boiler

- Check the expansion tank for correct air pressure, usually 12/15 psi.
- Inspect the closed loop for leaks.
- Inspect the motor and circulation pump for proper operation.

- Lock out and tag out electricity, water and circulating pump.
- Remove the burner assembly from boiler.
- Vacuum the fire box.
- Clean fire tubes with a metal brush and fin comb.
- Open junction boxes, inspect wiring and connections.
- Open the flow switch and check the switch with the Ohm/Volt meter.

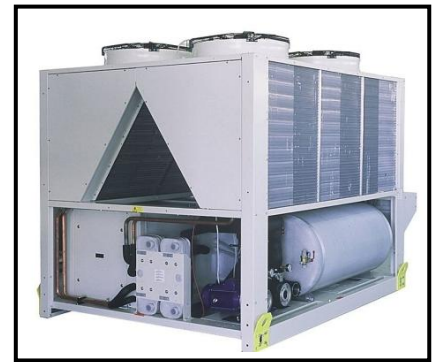
Figure 6: Chiller

- Compressor - check oil level through site glass.
- Lock out and tag out electrical chilled/condenser water and pumps.
- Inspect the isolation on the chilled water piping and chiller barrel.

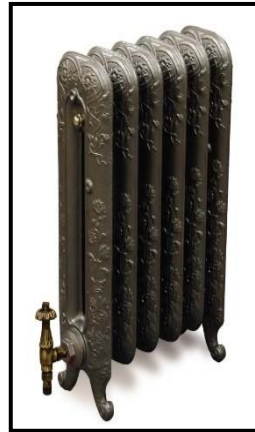
Figure 12: Cast Iron Radiator (older version)

- Keep the radiator clean of dust and lint.
- Bleed the system by opening the radiator valve and allow trapped air to escape –tighten the valve again when water runs out.

- Look for moisture near the supply valve –if a leak occurs replace the “packing”. Turn off the supply valve - loosen the packing nut - wrap the valve threads with the new sealer and tighten the nut down again- reopen the supply valve.
- Have the system flushed by a licensed HVAC technician.
- Connect a hose to the boiler drain and run it outside.
- Open the bleeder valve on the highest radiator in the house or building.
- Allow the system to drain.
- Open the water supply valve and run until the water comes clean from the hose.
- Close all the bleeder valves and start/run the boiler.

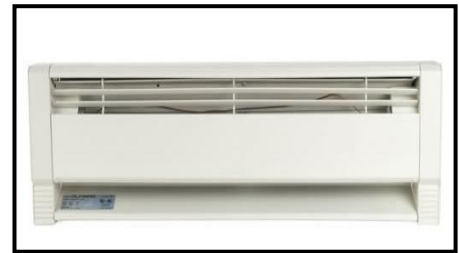
Figure 14: Electrical Baseboard

- Check and clean the electrical baseboard for lint and dust accumulation.
- Use a soft bristle brush or a can of compressed air to knock off contaminants from the coils; vacuum out the debris.
- Check the wire connections and ground wire.

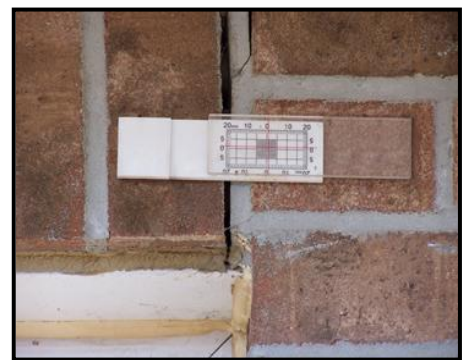
Figure 17: Crack Monitor Gauge

- Determine if the crack is active (continuing to expand) or relatively dormant by use of a crack monitor. A widening or shearing of the crack may indicate structural issues.
- Dormant hairline cracks can generally be left alone.
- Cracks smaller than $\frac{1}{16}$ of an inch can be repaired with a water and cement mixture. If it is wider add fine sand.
- Repairs can re-establish structural integrity with a dormant crack: remove loose concrete, clean exterior surface, inject epoxy inside the crack which will bond and adhere to both sides of the crack, remove the excess epoxy after seal is properly cured.
- If the crack is active; consultation from a structural engineer is required to determine the cause and recommend repairs.

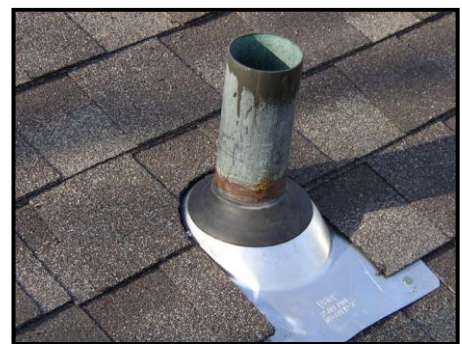
Figure 23: Flashing Around a Vent Pipe

- Make a patch large enough to fit under the shingles on either side of the damaged area – make sure it is tapered at the end.
- Taking care, break the seal around the damaged flashing and the surrounding shingles.

- Clean the damaged flashing with a wire brush and cut a slit into it.
- Place roofing cement around the boarder of the patch, slip the tapered end into the slit and fit the edges of the patch under the shingles.
- Place the square edge atop the damaged flashing, press to create a seal.
- Add additional cement to all seams and joints, ensure there is a smooth seal otherwise water will not flow properly.

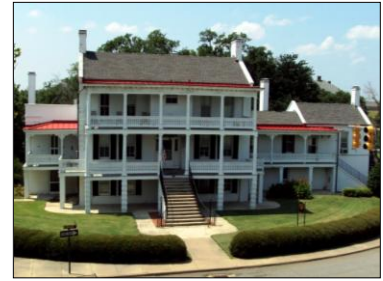
Building #: 1**Built:** 1819**Address:** 151 Bernard Road**Dimensions:** 48' 0" (five bays) x 32' 3"**Stories:** 3.0**NHL Status:** Contributing**Type:** Residential**VA State Inventory #:** 114-0002-0004

Description: Central block on double piles with two-story flanking wings, an above-ground basement and gabled roof. Porch is full façade, supported by octagonal columns and piers. **Basement:** Entry has a glazed, paneled wood door. Windows are six-over-six-light double sash. **First Floor:** The central entry has a glazed, paneled wood door. Windows are two-over-two-light double-hung sash. **Second Floor:** Six-light casement window, four-light fixed window and two-over-two-light double-hung sash window. **Interior:** Ornamental plaster dome above stairs; columns and rope molding at doors and windows casings; elliptical staircase; two marble and wood fireplace mantels; vaulted ceiling on the second floor bedrooms; quarter-sawn pine flooring; solarium floor with alternating light and dark stained boards; below-grade cistern; century-old radiators; built-in casework on all floor; paneled reveals.

Materials: Flemish bond brick walls built on a concrete and brick foundation. Asphalt roof shingles. Porch is wood with a tin roof, wood columns and brick piers. Floors are wood, with plaster over the brick walls.

Mechanical/Electrical Systems: **Electrical:** Exterior transformers to an exterior disconnect switch and circuit breaker. **Mechanical:** A gas boiler and three AC window units. Gas-fired water heater.

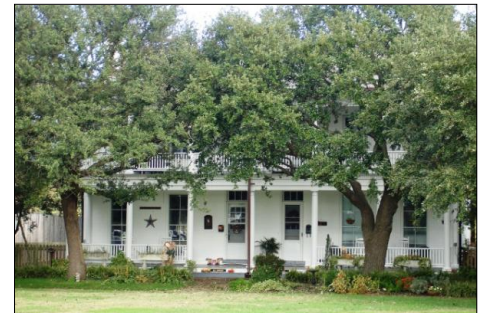
Building #: 3**Built:** 1875**Address:** 167 Bernard Road**Dimensions:** 51' 0" (six bay fronts) x 35' 0"**Stories:** 2.5**NHL Status:** Contributing**Type:** Residential**VA State Record #:** 114-0002-0016

Description: A symmetrical duplex with a front-facing T- floor plan and a full façade porch. The roof is cross gabled with broken pitch on the front elevation. Chimneys have corbelled caps. The building was remodeled in 1934 after being damaged by a fire. The porch is picketed with balustrades, Doric columns and pilasters, dentils and a full entablature. It runs the entire façade on the second story **First Floor:** Two central entries have paneled wood with twelve lights; three-light transoms. Windows are four-over-four-light double-hung sash with lintels and sills. **Second Floor:** Two central entries have three-light French doors. Windows are four-over-four-light double-hung sash with lintels and sills. Porch runs the full façade. **Interior:** Original stairs, flooring, window and door casings.

Materials: Brick walls (bricks painted white) built on a concrete foundation. Roof of main structure has asphalt shingles while the porch has a metal roof. Windows have masonry lintels and sills

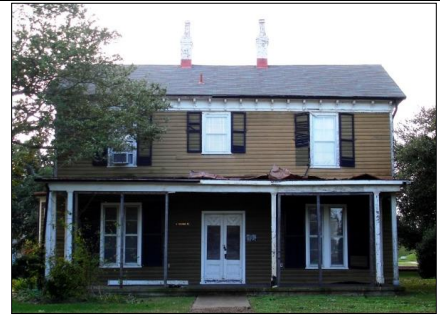
Building #: 14**Built:** 1880**Address:** 14 Ruckman Road**Dimensions:** 41' 0" (three-bay front) x 25' 6"**Stories:** 2.0**NHL Status:** Contributing**Type:** Residential

Description: Front facing T-plan with a symmetrical façade and full-façade porch. The roof is crossed-gabled with two (three total) central chimneys with pots; cornice brackets; and chamfered roof supports. **First Floor:** Central entry with paired glazed wood-panel doors and flanked by pairs two-over-two-light double-hung sash windows. **Second Floor:** Four-over-four double-hung sash windows; central window is six-over-six-light double-hung sash which are paired with pedimented casing.

Materials: Wood frame with asbestos siding, built on a concrete and brick foundation. Asphalt roof shingles. The porch is a wooden frame with a slightly-pitched metal roof and brick pier foundation (it is currently in poor condition).

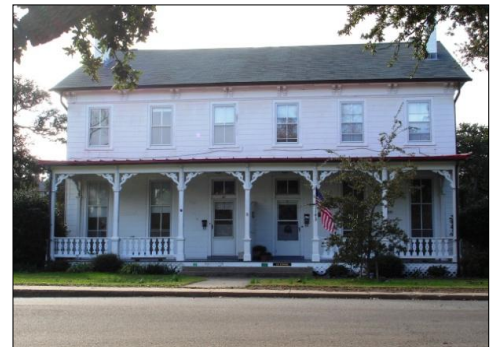
Building #: 15**Built:** 1878**Location:** 34 Ruckman Road**Dimensions:** 38'6" (six bay front) x 48'9"**Stories:** 2.0**NHL Status:** Contributing**Type:** Residential

Description: A symmetrical duplex with a front-facing T-plan and full façade porch. Cross gabled roof with six chimneys. Windows on both floors are two-over-two-light double-hung sash. **First Floor:** Two central entries with glazed wood panel doors. Porch is one story with a full façade; its roof is supported by chamfered posts with jigsaw-cut brackets and pilasters at the ends and jigsaw-cut balusters. **Interior:** Original windows and doors.

Materials: Main structure is a wood frame atop a concrete foundation and has asbestos-shingle siding. The porch is also of a wood frame as are the posts. The roof is asphalt shingle while the porch roof is metal.

Mechanical/Electrical Systems: **Electrical:** Exterior transformers to an exterior disconnect switch and circuit breaker. **Mechanical:** Gas boiler; central AC system. Gas-fired water heater.

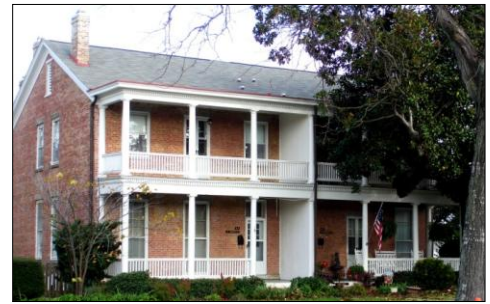
Building #: 16**Built:** 1878**Address:** 51 Bernard Road**Dimensions:** 51'0" (six bay front) x 36' 0"**Stories:** 2.5**NHL Status:** Contributing**Type:** Residential**VA State Record #:** 114-0002-0018

Description: A symmetrical duplex with a front-facing T-plan and full façade porch. Cross gabled roof. The six interior chimneys have corbelled caps. The porch is two stories, with picketed balustrades, Doric columns and pilasters. **First Floor:** Two central entries each having glazed wood paneled doors with transoms. Windows are four-over-four-light double-hung sash. **Second Floor:** Two glazed French doors. Windows are two-over-two-light double-hung sash. **Interior:** Original stairs, flooring, window and door casings.

Materials: Five course common brick bond (painted white) walls built on a concrete foundation. The roof has asphalt shingles. The porch has a wooden frame and metal roof. Windows have masonry lintels and sills.

Mechanical/Electrical Systems: **Electrical:** Services from exterior transformer to an exterior disconnect switch and an exterior circuit breaker panel board. **Mechanical:** Gas furnace; central AC system. Gas-fired water heater.

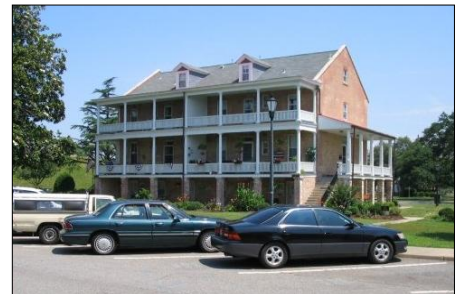
Building #: 17 and 18 (Tuileries)**Built:** 1823**Address:** 41 and 29 Bernard Rd**Dimensions:** 65' 0" x 37'9" and 18'0" x 23" 0"**Stories:** 3.0 (two stories over an above-ground basement)**NHL Status:** Contributing**Type:** Residential**VA State Record #:** 114-0002-0005 and 114-0002-0019

Description: Rectangular floor plan with a rear ell and three-story full façade porch. The gabled roof is corbelled out and inset with stone to form ornamental quarter-rounds. A single large chimney serves all fireplaces (8 in total). The roof is a broken pitch on the front elevation. Full length porch is supported by piers and topped with Tuscan columns. Third level porches were probably added in 1907. Entrances are at gable ends under the side porches. Windows on the first and second floors are four-over-four-light double hung sash. Entries for all floors are glazed paneled wood doors. **Basement:** Windows are two-over-two-light double-hung sash. **Interior:** Original stairs and some flooring. Building 17: closets on either side of the first place may be historic, fireplaces may be original.

Materials: According to the 1987 HABS report the building is a wood frame with Flemish bond brick veneer walls built on full raised brick foundations. Porches are supported by brick columns and have tin roofs. The main roof has asphalt shingles.

Mechanical/Electrical Systems: **Electrical:** Services from exterior transformer to an exterior disconnect switch and an exterior circuit breaker. **Mechanical:** AC duct system. Gas-fired water heater.

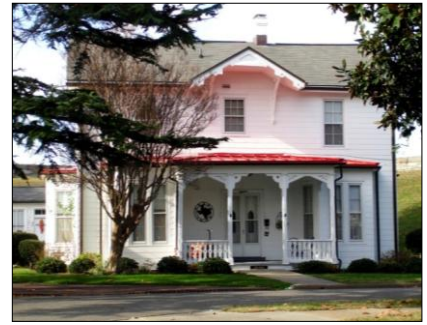
Building #: 19**Built:** 1880**Location:** 18 Bernard Rd**Dimensions:** 41'3" (three-bay front) x 25'6"**Stories:** 2.0**NHL Status:** Contributing**Type:** Residential**VA State Record #:** 114-0002-0020

Description: Symmetrical duplex with a front facing T- plan and a full-façade porch. One story bay on either side, only the northwest bay has windows. The central chimneys have corbelled tops. The porch has jigsaw brackets and balusters. **First Floor:** Central entry with a pair of glazed wood-panel doors. Windows are four-over-four light double-hung sash and two-over-two-light double-hung sash in the center of the bay window. **Second Floor:** Windows are four-over-four double hung sash and six-over-six double-hung sash under the center gable. **Interior:** Original slate fireplace mantels, hardware, moldings, quarter-sawn pine flooring, arched recessed in primary spaces, stair with turned balusters, acorn newels and a hardwood handrail

Materials: Wood frame built on a concrete foundation. Exterior walls are asbestos shingle. The roof has asphalt shingles. The porch is a wooden frame, brick foundation with a metal roof.

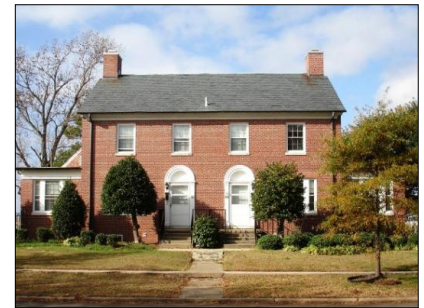
Dimensions: 42' 0" (four bay front) x 30' 0"**Stories:** 2.0**NHL Status:** Contributing**Type:** Residential**VA State Inventory #:** 114-0002-0021 through 114-0002-0024

Description: Rectangular plan with brick end sleeping and rear porches. Buildings 26 and 31 have a hipped roof, while buildings 25 and 30 have a gabled roof. Two interior end chimneys are visible from the exterior. The sleeping porches have tripartite windows. **First Floor:** Two doorways with pilasters and overlight with wooden tracery. Tripartite windows: six-over-six-light double-hung sash flanked by two-over-two-light double-hung sash. **Second Floor:** Windows are six-over-six light double-hung sash. **Interior:** Original windows and doors, including ten light paired French doors; casings and moldings; fireplace mantels; stairs and wood flooring.

Materials: Brick foundation, exterior walls are five course common brick bond and a slate roof. Sleeping porches have brick foundations, clapboarded walls and metal hipped roofs.

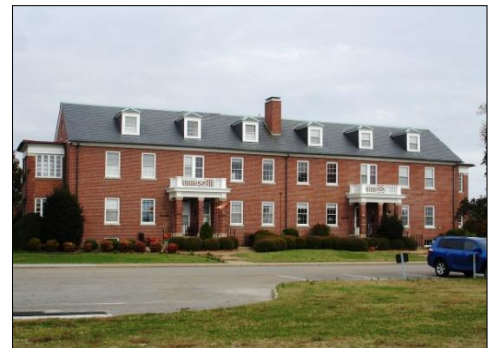
Dimensions: 100' 0" (twelve-bay front) x 29' 0"**Stories:** 2.5**NHL Status:** Contributing**Type:** Residential**VA State Inventory #:**

Description: Rectangular plan with two projecting two-bay porticos and end sleeping porches. The roof is gabled with a single central chimney. There are two, two-story sleeping porches each with flanking casemates, multi-paned fixed windows and a full entablature. Windows for both floors are six-over-six-light double-hung sash with jack arches and sills. First Floor: There are two, two-bay porticos. Second Floor: Paired four-over-four-light double-hung sash windows with jack arches and sills. There are six hipped dormers with six-over-six double-hung sash windows. Interior: Original windows and doors; casings and moldings; fire place mantels; stairs; wood flooring. Note: Building # 52B had a fire in 1936 which caused significant interior damage.

Materials: The main structure is built on a concrete foundation and has cinder block walls with a five course common bond brick veneer and a slate roof. The porticos have brick foundations with a concrete base and caps; wooden balustrades and a standing seam metal roof. The sleeping porches a standing seam metal roof. Window arches are brick and sills are concrete.

Mechanical/Electrical Systems: Electrical: Exterior transformers to an exterior disconnect switch and circuit breaker. Mechanical: Furnace, central AC system and sprinkler system. Gas-fired water heater.

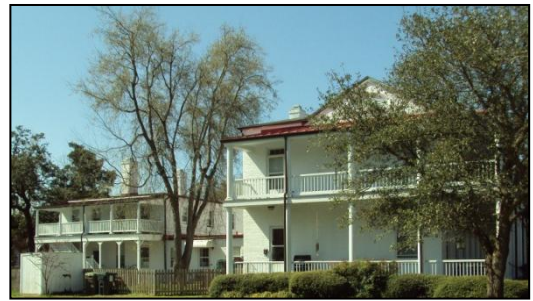
Building #: 50**Built:** 1834**Address:** 121 Bernard Road**Dimensions:** 50' (eight bays) x 47'6" and 23' 7" (four bays) x 27' 10"**Stories:** 2.0**NHL Status:** Contributing**Type:** Residential**VA State Inventory #:** 114-0002-0031

Description: Irregular T- shape grouping of three quarters (a duplex-50A and B connected to a single family dwelling-50C). A wrap-around porch wraps on the main façade of the duplex with Doric columns. A porch extends the width of the second building with Doric columns on the second floor. Entries for both the duplex and single family dwelling are glazed, paneled wood doors. The duplex has a gabled roof, a central chimney and two end chimneys. Duplex: First and Second Floors: Windows are six-over-six-light double-hung sash with painted brick sills and jack arches. Single Family Unit: First Floor: Windows are nine-over-nine-light double-hung sash. Single Family Unit: Second Floor: Windows are six-over-six-light double-hung sash.

Materials: The duplex is a wooden frame with five course English bond brick veneer walls. The roof has asphalt shingles. The porch is wood, supported by brick piers and a standing metal seam roof with simple wood railings and lattice work between piers. The single family building is a wooden frame constructed on a brick and concrete foundation, with a painted brick veneer and a standing seam metal hipped roof. The porch is wood, with wooden square piers on the first floor and wood Doric columns on the second. The roof is a standing metal seam. Chimneys are made of brick and painted white.

Mechanical/Electrical Systems: Electrical: Exterior transformers to an exterior disconnect switch and circuit breaker. Mechanical: Gas furnace; central AC system. Gas-fired water heater.

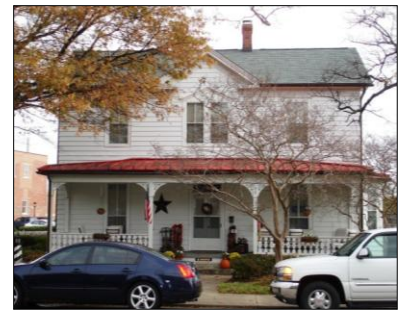
Building #: 55**Built:** 1886**Address:** 42 Ingalls**Dimensions:** 41' 0" (three-bay front) x 25'6"**Stories:** 2.0**NHL Status:** Contributing**Type:** Residential**VA State Inventory #:** 114-0002-0035

Description: Symmetrical duplex with a front-facing L-plan and full façade porch. Cross gable roof with a center gable and three interior chimneys with corbelled tops. Porch is single story with an extended slightly-pitched roof and jigsaw cut brackets and balusters. There are two one story side bays, with the south side having windows. Windows are two-over-two-light double-hung sash. First Floor: Central entry has paired, glazed wood-panel doors with transom. Second Floor: Center windows are paired with pedimented casing. Interior: Original reeded window and door casings; radiators; moldings; oak flooring and arched recesses in primary spaces; stairs with turned balusters; chamfered newels with beveled caps and stained hardwood handrail.

Materials: Wood frame with aluminum siding built on a brick and concrete foundation. Asphalt roof shingles. Wood framed porch with a metal roof and brick piers.

Mechanical/Electrical Systems: Electrical: Exterior transformers to an exterior disconnect switch and a circuit breaker. Mechanical: Gas boiler; central AC system. Gas-fired water heater.

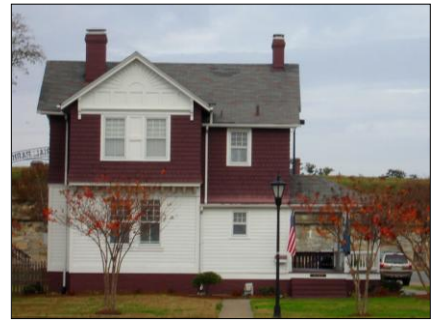
Building #: 60**Built:** 1890**Address:** 67 Fenwick**Dimensions:** 29' 2" (three-bay front) x 28' 6"**Stories:** 2.0**NHL Status:** Contributing**Type:** Residential**VA State Inventory #:** 114-0002-0036

Description: Irregular block floor plan and façade with a side porch. Cross gables roof with three interior chimneys. **First Floor:** Main entrance has a glazed wood-panel door; paired twelve-over-two-light double-hung sash windows and small six-over-one light double-hung sash window. The porch is a single story with a hipped roof. **Second Floor:** Paired twelve-over-two-light double-hung sash windows and nine-over-two double-hung sash windows. The floor is stepped out and bracketed. Gables are extended and bracketed featuring sunbursts and half timbering. **Interior:** Original fire place with reeded surround; wood fireplace mantel shelf with brackets; raised panel doors with period hardware; and random width pine floors and trim.

Materials: Wood frames built on a brick and concrete foundation. First floor exterior walls are wood clapboards, with wood shingles on the second floor and a clapboard gable. Roof has asphalt shingles.

Mechanical/Electrical Systems: **Electrical:** Exterior transformers to an exterior disconnect switch and circuit breaker. **Mechanical:** Gas boiler and gas-fired water heater.

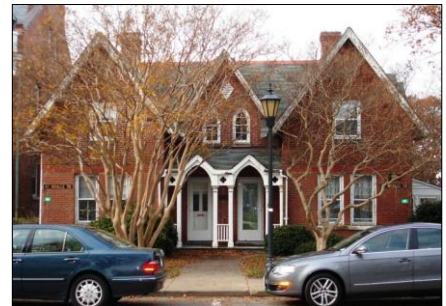
Building # 61**Built:** 1889**Address:** 43 Ingalls Road**Dimensions:** 43' 0" (six-bay front) x 16'0"**Stories:** 1.5**NHL Status:** Contributing**Type:** Residential**VA State Inventory #:** 114-0002-0037

Description: Rectangular duplex with a symmetrical façade and partial façade porch. Cross gabled roof. There are three interior chimneys have corbelled caps and brick work under the eaves. Porch is a single story with parallel gables and quatrefoil cut-outs, chamfered columns and pilasters, and pointed-arch entranceways. Both floors have four-over-four-light double-hung sash windows with jack arches. **First Floor:** Two central entries with jack arches, two glazed paneled doors. **Second Floor:** Two pointed-arch windows in the center wall dormer with four-over-four light double-hung windows and diamond-shaped louvered windows below the cornice of the wall dormer. **Interior:** Original stairs, windows and doors casings, possibly original wood flooring and built-in china cabinet.

Materials: Seven course common bond brick walls built on a concrete foundation, with asphalt roof shingles. Porch is a wooden frame with asphalt roof shingles. There are exposed rafters.

Mechanical/Electrical Systems: **Electrical:** Exterior transformers to an exterior disconnect switch and circuit breaker. **Mechanical:** Gas boiler; central AC system. Gas-fired water heater.

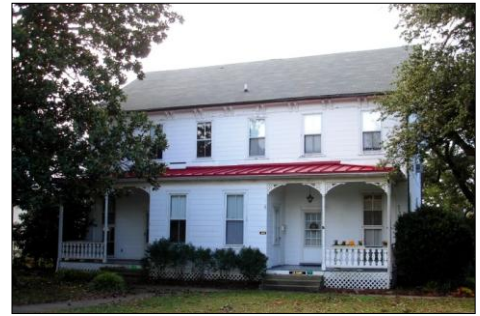
Building #: 62 and 63**Built:** 1889**Address:** 28 and 24 Ruckman Road**Dimensions:** 38' 6" (six-bay front) x 48' 9"**Stories:** 2.5**NHL Status:** Contributing**Type:** Residential**VA State Inventory #:** 114-0002-0038 and 114-0002-0039

Description: Symmetrical duplex, front-facing T- plan and wrap-around porch. Cross gabled roof with six chimneys. Paired cornice brackets and verge boards in the side gables. The porch has a hipped roof, jigsaw-cut brackets paired with cornice brackets with pendants. Windows are two-over-two light double-hung sash. **First Floor:** Two central glazed wood panel doors. **Interior:** Original reeded window and door casings; period hardware; moldings; built-in casework; wood flooring; front and rear stairs; reeded newel posts. Building 62: faux fainted slate and wood fireplace mantels; double porcelain laundry tubs; main stairs with ball newel caps and drop pendants. Building 63: incised slate fireplace mantels; main stairs with hardwood handrails; main fireplace retains a cast-iron coal grate.

Materials: Asbestos shingle siding built on a concrete foundation. Porch frame is wood with a metal roof. Roof is asphalt shingle.

Mechanical/Electrical Systems: **Electrical:** Exterior transformers to an exterior disconnect switch and circuit breaker. **Mechanical:** One gas boiler; base board heating system; six AC window units. Gas-fired water heater.

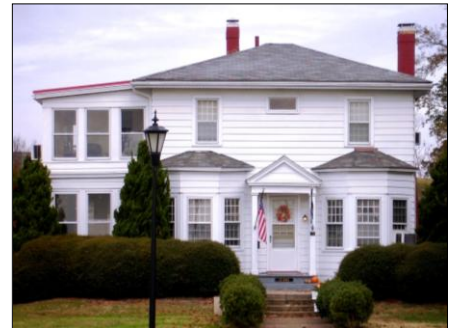
Building #: 64**Built:** 1934**Address:** 71 Fenwick**Dimensions:** 29' 2" (four-bay front) x 28' 6"**Stories:** 2.0**NHL Status:** Contributing**Type:** Residential**VA State Inventory #:** 114-0002-0040

Description: Rectangular floor plan with a one-story entrance portico and two story side sleeping porches; a hipped roof and two chimneys. The porch is pedimented with Doric piers. There are two tripartite bay windows. Both floors have twelve-over-twelve-light double-hung sash windows and one-over-one light double-hung sash windows in the porches. **First Floor:** A central entry with a glazed paneled door. **Second Floor:** Transom window. **Interior:** Brick fireplace and hearth with a wooden mantel; five paneled doors with period hardware; wood flooring and trim; plain casings and a straight run stair.

Materials: Wood frame built on a brick and concrete foundation. Siding is aluminum with an asphalt shingle roof on both the main structure and entrance portico. Porches are a wooden frame with a shed roof.

Mechanical/Electrical System: **Electrical:** Exterior transformers to an exterior disconnect switch and circuit breaker. **Mechanical:** One gas boiler and four AC window units. Gas-fired water heater.

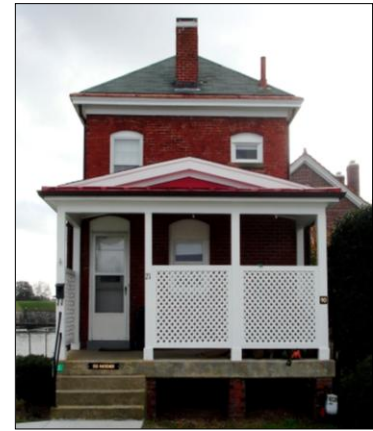
Building #: 90**Built:** 1900**Address:** 21 Moat Walk**Dimensions:** 20' 4" (three-bay front) x 28' 2"**Stories:** 2.0**NHL Status:** Contributing**Type:** Residential**VA State Inventory #:** 114-0002-0041

Description: Rectangular floor plan with a one-story rear ell, front/back porches and a raised basement. Two bay single story porch with three square columns and turned balusters. Windows on both floors are six-over-six-light double-hung sash with segmental arches. **First Floor:** Segmental arch over doorway made of three rows of header bricks. **Interior:** Original windows and doors; casing and moldings; stairs; wood flooring.

Materials: Stretcher bond brick walls built on a concrete foundation, with a brick water table. Porch has wooden columns and a metal roof. Asphalt shingles on the roof.

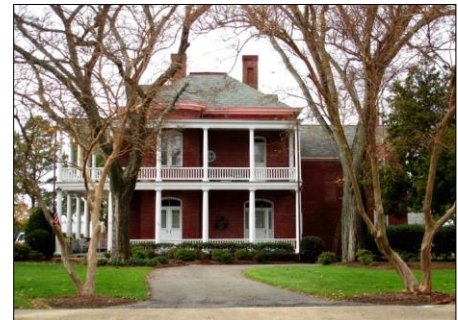
Building #: 93**Built:** 1884**Address:** 75 Ingalls Road**Dimensions:** 35' (two-bay front) x 44'**Stories:** 2.0**NHL Status:** Contributing**Type:** Residential**VA State Inventory #:** 114-0002-0042

Description: Rectangular floor plan with a side wing and two-story wrap-around porch, pedimented side dormers and four chimneys and picketed balustrade. Roof is hipped and pyramidal with a side gabled wing. The porch has a hipped roof with Doric columns. Entry on both floors is through wood-paneled paired glazed doors with segmental arches. Windows are one-over-one-light double hung sash with segmental arches and stone stills. **Second Floor:** Rounded window. **Interior:** Original pocket doors and staircase; fluted pilaster trim; corner blocks; arched openings into bays on the first and second floors.

Materials: Eight course common-bond brick walls built on a concrete and brick foundation. Asphalt-shingle roof and siding on the side dormers. Porch is a wooden frame on a brick foundation with a tin roof.

Mechanical/Electrical Systems: **Electrical:** Exterior transformers to an exterior disconnect switch and circuit breaker. **Mechanical:** Heat pump; central AC system and two AC window units. Gas-fired water heater.

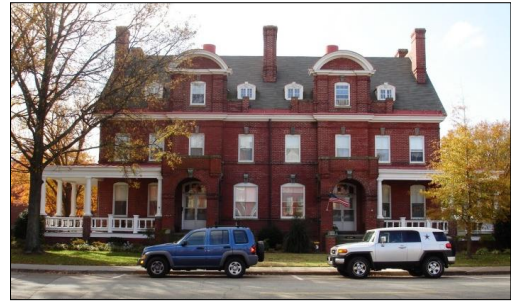
Building #: 101, 102 and 103**Built:** 1906**Address:** 55, 59 and 63 Ingalls Road**Dimensions:** 32'0" (eight-bay front) x 72' 5"**Stories:** 2.5**NHL Status:** Contributing**Type:** Residential**VA State Inventory #:** 114-0002-0043, 114-0002-0044, 114-0002-0045

Description: Rectangular plan with two rear wings, a gabled roof with three chimneys and one central chimney. Porches are on three sides with arched openings and sawn balusters. There is a raised basement. First and second floor both have double glazed raised panel doors with segmental arches and curved three-light overlights. Windows are two-over-two-light double-hung sash with arches. First Floor: Windows have jack arches. Second Floor: Windows have segmented arches. There are two large dormers with arched six-over-six-light double-hung sash with segmental arches. Four small dormers, curved with four-light casement windows with wood keystones. Interior: Built-in sideboard; fireplace mantel with mirrors; original windows and doors; original moldings; stairs with bracketed stringers; and original wood flooring. Building 101: Has original window and door casings.

Material: Stretcher bond brick walls built on a concrete and brick foundation, with sting course at the first and second levels and below the eaves. There is also a brick splash course and an asphalt shingle roof. Porches are brick with wood columns; decorate elements include brick pilasters and iron work in the arches. Decorative elements on windows include masonry keystones.

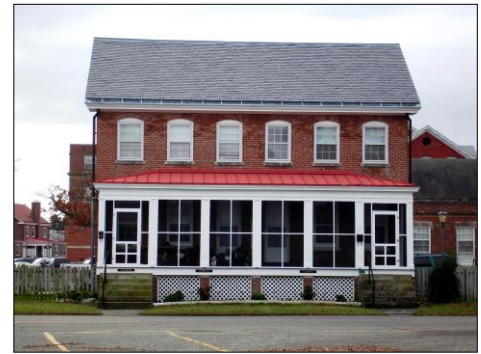
Buildings #: 109, 110 - 115, 130, 131, 132, 140, 148, 149, 150 - 156**Built:** 1906 and 1911**Address:**

Building Materials: Stretcher bond brick walls built on a concrete and brick foundation with a brick water table. The roof has asphalt shingles. Windows have limestone sills. The porches have wood columns and standing seam metal roofs. Buildings 140, 148, 149 and 150 have terra cotta tiled roofs.

Mechanical/Electrical Systems: **Electrical:** Exterior transformers to an exterior disconnect switch and circuit breaker. **Mechanical:** Central AC duct systems. Gas-fired water heater.

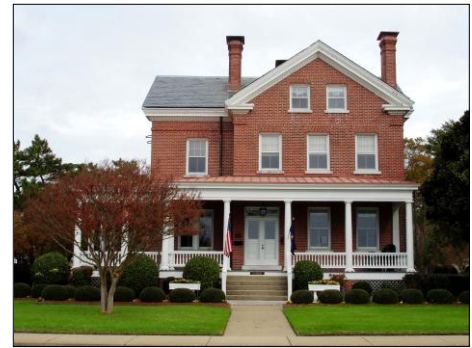
Buildings #: 118, 120 and 125**Built:** 1908**Address:** 29 and 37 Fenwick Road; 73 Ingalls Road**Dimensions:** 28'1" (four-bay front) x 42'**Stories:** 2.5**NHL Status:** Contributing**Type:** Residential**VA State Inventory #:** 114-0002-0053, 114-0002-0055 and 114-0002-0059

Description: Front facing and cross gable with a raised basement and four chimneys. Windows on the first and second stories are six-over-two-light double-hung sash with jack arches. There is a single story wraparound porch with columns, turned balusters and stair rail. **First Floor:** Double glazed, raised panel doors with four-light transom and jack arch. **Second Floor:** Two, six-over-two-light double-hung sash windows on the front-facing gable. **Interior:** Original windows and doors; stairs with bracketed stringers; wood flooring; built-in casework in pantry.

Materials: Stretcher brick bond walls built on a brick and concrete foundation, with a slate roof and stone water table. Windows have stone sills. Porch has brick piers with wood columns and concrete steps. The chimneys have corbelled brick and stone caps; brick coursing over the second story windows and a dentiled cornice.

Mechanical/Electrical Systems: **Electrical:** Exterior transformers to an exterior disconnect switch and circuit breaker. **Mechanical:** Central AC duct system. Gas-fired water heater.

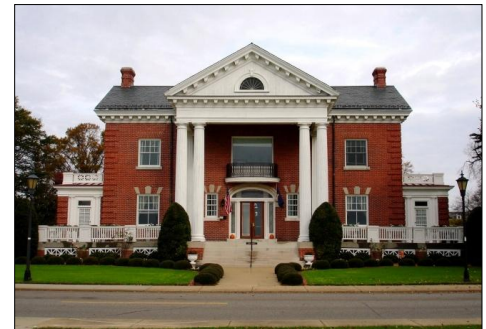
Buildings #: 119 and 1087 (the gazebo)**Built:** 1907**Address:** 33 Fenwick Road**Dimensions:** 63' 0" (five-bay front) x 28' 0"**Stories:** 2.0**NHL Status:** Contributing**Type:** Residential**VA State Inventory #:** 114-0002-0054 and 114-0002-0285 (gazebo)

Description: Rectangular floor plan with a projecting central block, full height porch and side porches. Roof is gabled with a central cross gable; the main porch is paired full-height fluted columns, pedimented with half round window and square balusters. Side porches have engaged columns, glazed doors, transoms and jalousie windows. There are five chimneys with corbelled caps. Windows on the first and second floor are eight-over-two-light double-hung sash with jack arches and voussoirs. **First Floor:** Double glazed door with sidelights. **Second Floor:** Large, plate glass window in the center. **Interior:** Original: fireplace mantels, multi-light French doors and transoms, pockets doors; staircase; and possibly the flooring. **Bldg 1087 (gazebo):** is located in the formal, landscaped garden behind the house. It is hexagonal in shape with hexagonal columns and embellished with arches, lattice and a balustrade. The roof is bell-shaped with jigsaw trim.

Materials: Stretcher bond brick walls built on a concrete and brick foundation, with a slate roof. First floor door has a limestone arch and leaded fanlight. Windows have limestone keystones; side porches have brick quoins; wrought iron railing on the balcony and concrete steps. The gazebo has a copper roof.

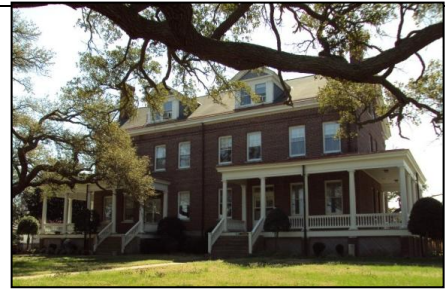
Dimensions: 21'10" (eight-bay front) x 58'10"**Stories:** 2.5**NHL Status:** Contributing**Type:** Residential**VA State Inventory #:**

Description: Rectangular floor plan with a gable roof, six chimneys, two rear ells and two single story wrap-around porches. Porches have columns, turned baluster and stair rails. Windows on the first and second floors are six-over-two-light double-hung sash with jack arches and sills. **First Floor:** Double glazed, raised panel doors with four-light transom and jack arch. **Second Floor:** Two gabled dormers with double hung six-over-two light double hung sash windows, cornice and paneled corner boards. **Interior:** Original window and doors; stairs with bracketed stringers; wood flooring. (*127B has the original wood flooring and stairs with bracketed stringers)

Materials: Five course common brick bond walls built on a concrete and brick foundation with a brick and stone water table. Roof has asphalt shingles. Windows have stone sills; on the second floor there are wood shingles in the gable above the window and projecting brick. Porches have brick piers, wood columns and concrete steps. Chimneys have corbelled bricks and stone caps.

Mechanical/Electrical Systems: **Electrical:** Exterior transformers to an exterior disconnect switch and circuit breaker. **Mechanical:** Gas furnaces; central AC system. Gas-fired water heater.

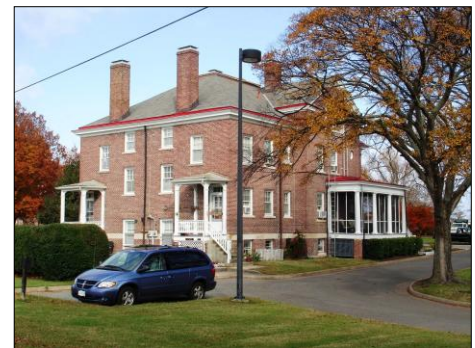
Building # 129**Built:** 1909**Address:** 101 Ingalls Road**Dimensions:** 25'0" (seven-bay façade) x 49'2"**Stories:** 2.5**NHL Status:** Contributing**Type:** Residential**VA State Inventory #:** 114-0002-0063

Description: Rectangular duplex with a cross gable roof in the front, a hipped roof in the rear and raised basement. Chimneys have corbelled caps. There are two, one story porches. Windows on both floors are six-over-two-light double-hung sash with jack arches and sills. Three windows are in the cross gable, two are four-over-two-light double-hung sash. **First Floor:** Glazed, raised panel front door with three-light transom and brick jack arch. **Interior:** Original windows and doors, casings and moldings; stairs with bracketed stringers; wood flooring; historic bathroom fixtures in attic bath; built-in cupboard and radiator with warming oven in dining room.

Materials: Five course common bond brick walls built on a brick and stone foundation. Asphalt roof shingles, a dentilled cornice and projecting brick course. The HABS report lists a brick water table with a stone splash course.

Mechanical/Electrical Systems: **Electrical:** Exterior transformers to an exterior disconnect switch and circuit breaker. **Mechanical:** One gas boiler; six AC window units. Gas-fired water heater.

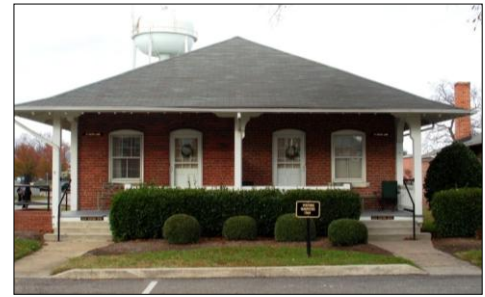
Building #: 136 and 137**Built:** 1909**Address:** 17 and 21 Hatch Lane**Dimensions:** 32' 3" (four-bay front) x 52' 6"**Stories:** 1.0**NHL Status:** Contributing**Type:** Residential**VA State Inventory #:** 114-0002-0067 and 114-0002-0068

Description: Rectangular duplex with a double-shotgun floor plan. Roof is hipped with flared eaves and exposed false rafter ends. The porch is two bays wide with square columns and brackets. There are small ells added to each side in the rear, each featuring a brick chimney at the ends and third central chimney. **First Floor:** Two doorways with six-over-two-light double-hung sash windows with segmental arches made of two rows of headers. **Interior:** Some original windows and doors, casings and moldings; wood flooring.

Material: Five course common bond brick walls built on a stone foundation. Roof has asphalt shingles. Windows have limestone sills. Porch has wood columns.

Mechanical/Electrical Systems: **Electrical:** Exterior transformers to an exterior disconnect switch and circuit breaker. **Mechanical:** Central AC system. Gas-fired water heater.

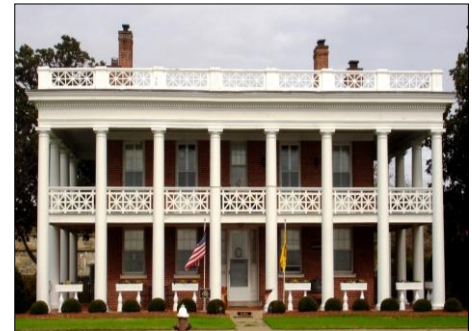
Building #: 141 and 142**Built:** 1910**Address:** 53 and 51 Fenwick Road**Dimensions:** 44' 0" (five-bay front) x 56' 0"**Stories:** 2.0**NHP Status:** Contributing**Type:** Residential**VA State Inventory #:** 114-0002-0070 and 114-0002-0071

Description: Rectangular floor plan with a monumental thirteen bay, wraparound porch and built-up roof. There are fourteen full height columns and second floor balustrade. There are four chimneys with corbelled caps. Windows on both floors are six-over-six-light double-hung sash. **First Floor:** Double glazed doors with sidelights. **Second Floor:** The windows are in the center flanked by three light casement windows. **Interior:** Original windows and doors, stairs and wood flooring; large louvered skylight over stairway hall.

Materials: Five course common bond brick walls built on a brick and concrete foundation with wood columns.

Mechanical/Electrical Systems: **Electrical:** Exterior transformers to an exterior disconnect switch and circuit breaker. **Mechanical:** Gas furnaces; central AC system. Gas-fired water heater.

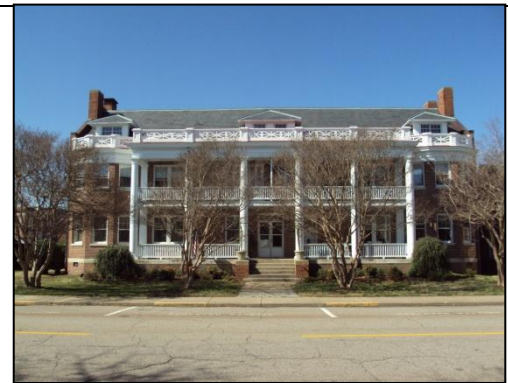
Building #: 143 and 144**Built:** 1910**Address:** 35 and 41 Ingalls Road**Dimensions:** 55'3" (eleven-bay front) x 64'5"**Stories:** 2.5**NHL Status:** Contributing**Type:** Residential**VA State Inventory #:** 114-0002-0072 and 114-0002-0073

**Description:** Rectangular block plan with a rear ell and gabled roof.

There is a two story, two level, five-bay porch with six full-height columns and square balustrades. The porch roof has a balustrade and dentil cornice. Four interior end chimneys attached in pairs at the roof ridge and one central chimney. There is a raised basement; exposed, sawn rafter ends on the sides and rear wings and site parapet walls. Both floors have six-over-one-light double-hung sash windows and bay windows. First floor: Double front door with jack arch and five light transoms. Second Floor: Windows have jack arches and there are three hipped dormers with bracketed eaves. Interior: Original windows and some doors, including pocket doors, casings and moldings; original stairs and quarter-sawn wood flooring; built-in casework; bay windows in dining room.

Materials: Five course common bond brick walls built on concrete foundation with a stone water table. The roof has slate shingles. Porch columns are made of wood and there are concrete steps. There is stone coping at the chimney and roof ridge.

Mechanical/Electrical Systems: Electrical: Exterior transformers to an exterior disconnect switch and circuit breaker. Mechanical: One gas boiler; central AC system. Gas-fired water heater. Buildings equipped with a sprinkler system.

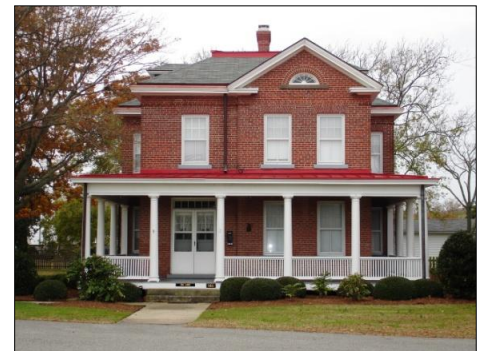
Building #: 146**Built:** 1910**Address:** 146 Engineer Lane**Dimensions:** 16' 0" (three-bay fronts) x 36' 4"**Stories:** 2.0**NHL Status:** Contributing**Type:** Residential**VA State Inventory #:** 114-0002-0074

Description: Rectangular plan with side wings and side dormers. Roof is hipped with a cross gable. Both floors have six-over-two-light double-hung sash windows with jack arches and sills. The porch wraps around on three sides, has eleven bays, columns and square balusters. There are two chimneys with corbelled caps and there is a half round window in the gable on the façade. First Floor: Double front door with six-light transom. Interior: Original windows and doors, casings and moldings; stairs; wood flooring.

Materials: Five course common brick bond walls built on a brick and concrete foundation. Roof has asphalt shingles; limestone window sills; wood porch columns; and projecting brick below the eaves.

Mechanical/Electrical Systems: Electrical: Exterior transformers to an exterior disconnect switch and circuit breaker. Mechanical: One gas boiler; central AC system. Gas-fired water heater.

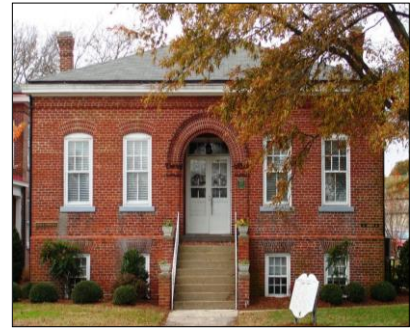
Building #: 147**Built:** 1910**Address:** 147 Engineer Lane**Dimensions:** 39' 0" (five-bay front) x 32' 6"**Stories:** 1.0**NHL Status:** Contributing**Type:** Residential**VA State Inventory #:** 114-0002-0075

Description: Rectangular floor plan with a single hipped roof. There are two interior chimneys with corbelled caps and a raised basement with six-over-six-light double-hung windows with jack arches. **First Floor:** Arched opening with pilasters; inside a recessed doorway has double glazed doors with five-light transom and jack arch. The windows are six-over-two-light double-hung sash with segmental arches made of three rows of header bricks. **Interior:** Original windows and doors, casings and moldings; stairs; wood flooring.

Materials: Five course common brick bond walls built on a concrete and brick foundation with brick and concrete steps. Roof has asphalt shingles and windows have brick arches.

Mechanical/Electrical Systems: **Electrical:** Exterior transformers to an exterior disconnect switch and circuit breaker. **Mechanical:** Gas furnace; central AC system. Gas-fired water heater.

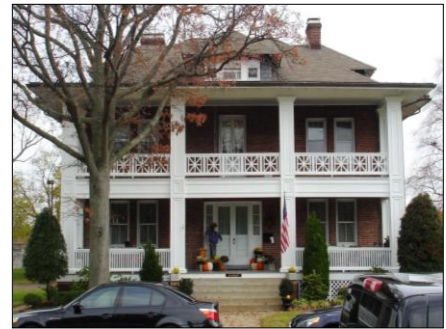
Building #: 157 and 158**Built:** 1911**Address:** 101 Bernard Road and 32 Ingalls Road**Dimensions:** 48' 4" (five-bay front) x 33' 5"**Stories:** 2.5**NHL Status:** Contributing**Type:** Residential**VA State Inventory #:** 114-0002-0085 and 114-0002-0086

Description: Rectangular floor plan with a raised basement and rear ell. Roof is hipped with a hipped cross gable at the rear. There is a two story, two level, three-bay porch with square columns and balusters on the first floor and decorative balustrade on the second. **First Floor:** Double glazed, raised panel door with sidelights. Windows are paired six-over-two-light double-hung sash with jack arches and sills. **Second Floor:** French doors in center that are flanked by six-over-two-light double-hung sash windows with jack arches. **Interior:** Fireplace mantels; original windows and doors, including two pairs of pocket doors, casings and moldings; stairs with turned spindles; wood flooring. Building #157: Built-in casework in the pantry. Building #158: Historic bathroom fixtures in the attic bathroom.

Material: Flemish bond brick walls built on a concrete foundation with a limestone splash course. The steps are concrete and brick with limestone trim. Roof has asphalt shingles; windows on the first floor have limestone sills; porch columns are wood. There are exposed jigsawn rafter ends.

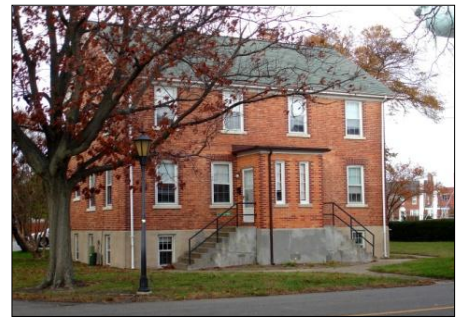
Building #: 167**Built:** 1921**Address:** 7 Patch Road**Dimensions:** 30' 6" (four-bay front) x 41' 0"**Stories:** 2.0**NHL Status:** Contributing**Type:** Residential**VA State Inventory #:** 114-0002-0087

Description: Rectangular floor plan with a front vestibule, raised basement and one interior chimney. Roof is gabled. Both floors have six-over-six double-hung sash windows with jack arches and sills. There is an arched window in the rear elevation. **First Floor:** Two tall, slim four-light fixed sash windows in the projecting vestibule (entries on sides). **Second Floor:** Half rounded windows on the gable ends. **Interior:** Original windows and doors, casings and moldings; stairs; wood flooring; varied colored bricks at the corners and the window/door surrounds.

Material: Stretcher bond brick walls built on a concrete foundation. Roof has asphalt shingles. Windows on both floors have limestone sills. Bricks surrounding the windows are red, while others are lighter.

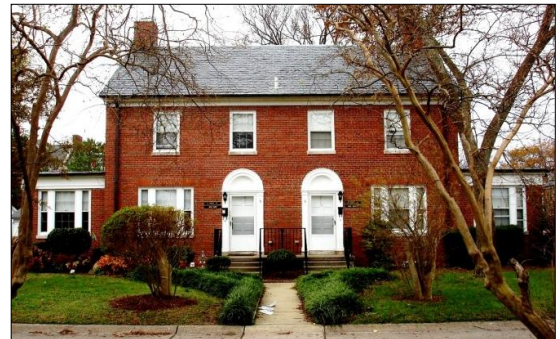
Dimensions: 42' (four-bay front) x 30'**Stories:** 2.0**NHL Status:** Contributing**Type:** Residential**VA State Inventory #:** 114-0002-0088 through 114-0002-0096

Description: Rectangular floor plan flanked by sleeping porches on each gable and rear porches. Buildings 186, 187 and 188 have a projecting front vestibule. Roof is hipped on Buildings: 186, 187, 188, 192, 194 and 196. Roof is gabled on Buildings: 191, 193 and 195. There are two interior end chimneys. Sleeping porches have tripartite windows. **First Floor:** Two doorways with pilasters, a fanlight and tracery, full entablature and a raised panel door. There are tripartite windows which are six-over-six-light double-hung sash and flanked by two-over-two-light double-hung sash. **Second Floor:** Windows are six-over-six-light double hung sash. **Interior:** Original windows and doors, casings and moldings; fireplace mantels; stairs; wood flooring. Building 186 also has ten-light paired French doors.

Materials: Five course common bond brick walls built on a concrete foundation. Roof is slate and door tracery is wood. Sleeping porches have brick foundations, clapboard walls and metal hipped roofs.

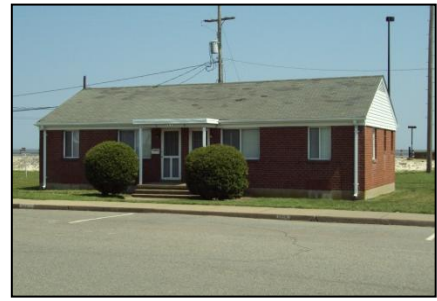
Stories: 1.0**NHL Status:** Contributing**Type:** Residential**VA State Inventory #:** 114-0002-0097 114-0002-0098 114-0002-0103

Description: Rectangular block duplex. The roof has a side gable. Windows are two-light horizontal sliding glass. Entrance is accentuated by a flat-roofed canopy supported on pipe columns.

Materials: Stretcher brick bond veneer walls built on a reinforced concrete and brick pier foundation. The roof is asphalt shingles. Clapboards are under the gable ends. The entrance columns are steel.

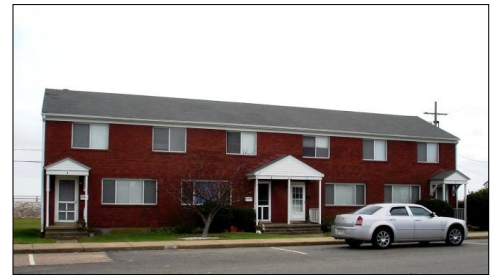
- 114-0002-0099 to 114-0002-0102
- 114-0002-0104 to 114-0002-0125 and 114-0002-0127 to 114-0002-0128

Description: Rectangular floor plan. Windows are two-light horizontal sliding glass. Entrances are accentuated by gable roofed canopies supported by pipe columns. Buildings: 304, 307, 311, 316, 324, 344, 350, 356 and 458 have Dutch gable-roofs. Buildings: 303, 305, 309, 318, 346, 348, 354, 452, 456 and 458 have three dormers with side walls and gables. Remaining roofs have side gables. Building 322 and 314 have a projecting center gable roof creating an entrance overhang; it is accentuated by full height columns and a broken triangular piedmont.

Building: Stretcher brick bond veneer walls built on a reinforced concrete and brick pier foundation. Roof has asphalt shingles. Clapboards are under the gable ends. Canopy supports are steel.

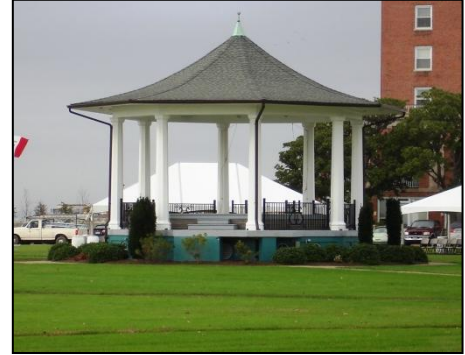
ADMINISTRATIVE**Building #: 4****Built:** 1934**Address:** In Continental Park**Dimensions:** 31' 0" x 31' 0"**Stories:** 1.0**NHL Status:** Contributing**Type:** Administrative**VA State Inventory #:** 114-0002-0189

Description: Octagonal gazebo with a raised basement and conical roof. Entrance to the basement is through a wood paneled door. The roof is supported by Doric columns and constructed with I-beams with wood cladding. There is a full entablature; low hedge of clipped ligustrums (shrubs) around the base; and the railing is has a lyre motif.

Materials: Wood and concrete construction built on a concrete foundation with asphalt shingles and wrought iron railing.

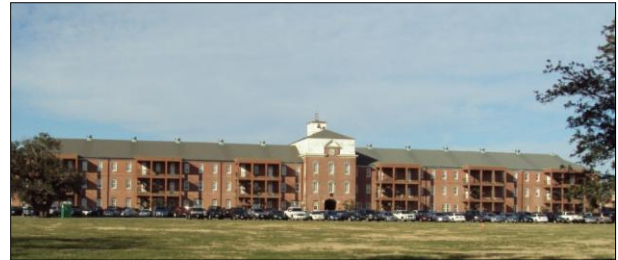
Building #: 5**Built:** 1879**Address:** 5 North Gate Road**Dimensions:** 446'0" (forty-five bay front) x 60' 2"**Stories:** 3.0**NHL Status:** Contributing**Type:** Administrative**VA State Inventory #:** 114-0002-0129

Description: Rectangular floor plan, symmetrical façade, side wings and staircases. The center block has a mansard roof, with hipped wings. The porch is three stories with a flat roof covering stairwells. An addition in 1938 and in 1900 the roof was raised. Windows for all floors are six-over-six-light double-hung sash with segmental arches and sills. **First Floor:** The main entrance includes a vaulted passage with a segmented arch flanked by four-light paneled doors with three-light transoms. The side wings have double paneled doors with transoms and set in segmental arches and sills. **Second and Third Floors:** Have double paneled doors with transoms set in segmental arches. **Details:** A large clock below pediment of the wall dormer on the main building and a drip mold.

Materials: Seven course common bond brick walls built on a concrete and brick foundation. Stairwells are brick; roof has asphalt shingles and arches on the main floor are stone. Window and door sills are masonry.

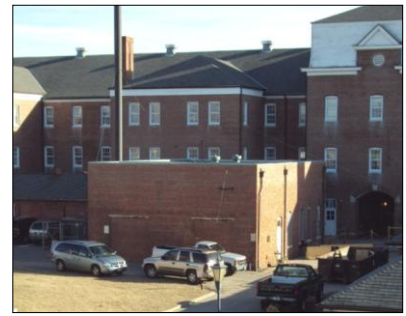
Building # 6**Built:** Circa 1900**Address:** 6 North Gate Road**Dimensions:** 51' 10" (five-bay front) x 36' 3"**Stories:** 1.0**NHL Status:** Contributing**Type:** Administrative**VA State Inventory #:** 114-0002-0130

Description: Rectangular floor plan with a built-up roof. This building has a 5,000 gallon AST. **First Floor:** Segmental arch over raised panel door and a two-light transom. Windows are six-over-six-light double-hung sash under segmental arches with sills and eight-light casement windows.

Materials: Five course common bond brick walls built on a concrete foundation with two courses of projecting brick near the bottom of the wall. Window sills are limestone.

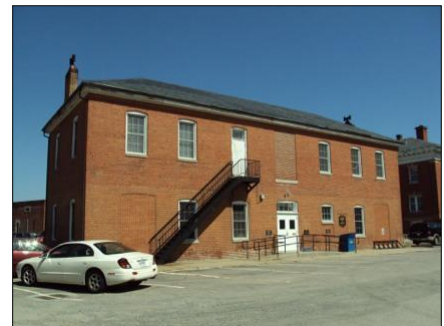
Building #: 7**Built:** 1880**Address:** 7 Bernard Road**Dimensions:** 80' 4" (eight-bay front) x 30' 4"**Stories:** 2.0**NHL Status:** Contributing**Type:** Administrative**VA State Inventory #:** 114-0002-0131

Description: Rectangular, block floor plan. Roof is hipped, with three chimneys. Windows on both floors are six-over-six-light double-hung sash with segmental arches and sills. The current porch was added in 1968; a pedimented two-story, three-bay porch was removed in 1958. The roof was raised to add a second story around 1900. **First Floor:** Central entry with two paneled glazed doors, a four-light transom door and step. A partially bricked window with three-over-three-light fixed sash, segmental arch and sill. **Second Floor:** A wood door in segmental archway with transom and step. **Interior:** Original wooden stairs; hall is lined with original beaded tongue-and-groove wainscoting; cast iron columns on the first and the second floor; original pressed tin ceilings is currently hidden by acoustic tile

Materials: Seven courses common bond brick walls on the first floor; five courses common bond brick walls on the second floor; nine and six courses between floors; built on a concrete foundation. Roof has slate shingles, with a tin ceiling. Step at main entry and window sills are stone. Step at the second floor is concrete. Doorways on both floors are made of brick. The porch is made of metal and there are several cast iron columns. There are bricked doorways on the first and second floors.

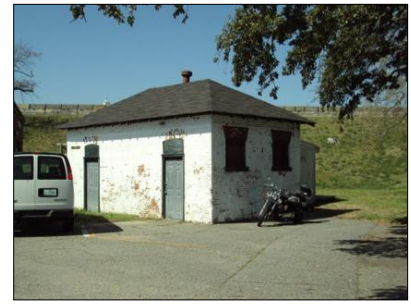
Building #: 8**Built:** 1887**Address:** 8 Bernard Road**Dimensions:** 25' 10" (two-bay front) x 15' 2"**Stories:** 1.0**NHL Status:** Contributing**Type:** Administrative**VA State Inventory #:** 114-0002-0132

Description: Symmetrical, rectangular block floor plan. The roof is hipped. Entry has two segmental arches with paneled doors, transom and boarded transom. Addition was added in 1904.

Materials: Five course common bond brick walls (painted white) built on a concrete foundation. Entry doors are wood; the roof has asphalt shingles; and there are exposed rafters.

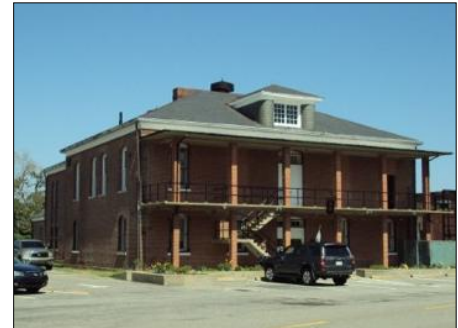
Building #: 9**Built:** 1900**Address:** 10 Bernard Road**Dimensions:** 45' 4" (five-bay) x 60' 4"**Stories:** 2.5**NHL Status:** Contributing**Type:** Administrative**VA State Inventory #:** 114-0002-0133

Description: Rectangular building with a rear wing, hyphen and rear ell. Ornaments are on the roof at junctions of slopes. 1902 a rear ell was added and in 1959 the cast iron porch was removed. The roof is hipped with two chimneys. There is a two-story, two-level front porch on piers with a railing. Doors on the first and second floor are similar - a double door with six-light-overlight and segmental arch. Windows on both floors are two-over-two light double-hung with segmental arches and sills. The central dormer is hipped with two twelve-light fixed sash windows; side walls that curve around the front and meet the window jambs.

Material: Stretcher bond brick walls built on a concrete foundation. The roof has slate shingles. Doors are steel. Window sills on both floors are limestone. Dormer side walls are slate. The porch has brick piers, concrete floors, metal stairs and iron pipe railings. There is a low brick water table on the building. Interior: There are cast iron columns and a section of pressed metal ceiling.

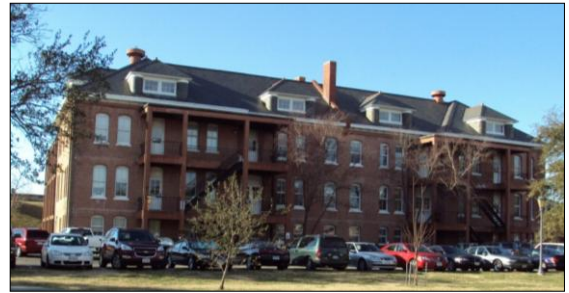
Building #: 10**Built:** 1902**Address:** 11 Bernard Road**Dimensions:** 153' 10" (eighteen-bay front) x 42' 0"**Stories:** 3.5**NHL Status:** Contributing**Type:** Administrative**VA State Inventory #:** 114-0002-0134

Description: U-plan with a three-part façade, where the central block is recessed. The roof is hipped. Windows on all floors are two-over-two light double-hung sash with jack arches and sills. There are four hipped dormers on the main façade with two six-light fixed-sash windows in each. Five stair towers provide access to all floors. A firewall is in the center with corbelling at the eaves, two central chimneys but six total, ornaments on the roof and a dentilled cornice. **First and Second Floors:** Two double raised panel, glazed doors with jack arches. **Third Floor:** Two single, raised panel, glazed doors with jack arches.

Materials: Stretcher bond brick walls built on a concrete foundation. The roof has slate shingles. Window jack arches are brick with masonry sills. Third floor door jack arches are brick. Dormers have slate shingles on the sides. There is a low brick water table on the building with a projecting brick course below the eaves. Ornamentation is either wood or metal.

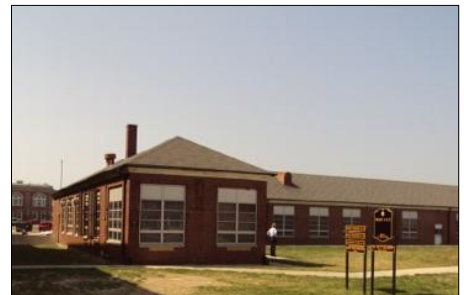
Building # 11**Built:** 1934**Address:** 3 Fenwick Road**Dimensions:** 200' 5" (sixteen-bay front) x 30' 9"**Stories:** 1.0**NHL Status:** Contributing**Type:** Administrative**VA State Inventory #:** 114-0002-0135

Description: Front-facing L - plan with an addition. Roof is cross hipped. There is an end chimney and eyebrow dormers with louvers. **First Floor:** Two paneled glazed doors, one wood door and jalousie windows with sills.

Building Materials: Five course Flemish-bond brick walls built on a concrete foundation. Roof has asphalt shingles. The addition has a shed roof. Jalousie windows have concrete sills.
