Table of Contents

Fort Monroe	Mothball Project	2011
4.3.2: Cast Iron (Brief 27)		27
4.3.3: Rust on Metal Roofing:		28
4.4: Roofs		28
4.4.1: Wood Shingles (Brief 19)		28
4.4.2: Asphalt Shingles		29
4.4.3: Slate Shingles (Brief 29)		29
4.4.4: Built Up Roofing System		30
4.4.5: Flashing		30
4.5: Lead Base Paint and Asbestos		31
4.5.1: Previous work		31
4.5.2: Regulations		31
4.5.3: Lead Base Paint		32
4.5.4: Asbestos		33

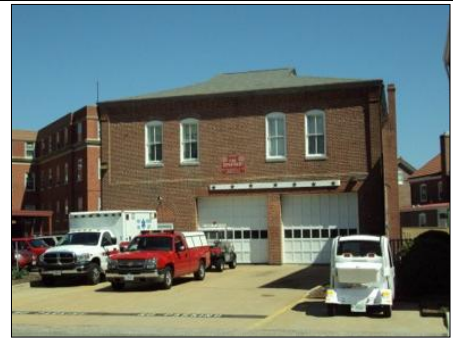
Building # 24**Built:** 1881**Address:** 1 Ruckman Road**Dimensions:** 46' 6" (three-bay front) x 40' 4"**Stories:** 2.0**NHL Status:** Contributing**Type:** Administration**VA State Inventory #:** 114-0002-0137

Description: Rectangular floor plan with an asymmetrical façade. There is a hipped roof with side-gable, one semi-exterior end chimney and a recessed second story wall with brick corners that suggest pilasters with a corbelled capital and cornice. Joist ends are visible over garage doors. **First Floor:** A paneled door with a fanlight and a glazed, paneled overhead garage door. **Second Floor:** Windows are two-over-two-light double-hung sash with segmental arches and sills. **Interior:** Original painted cast iron columns with ornamental caps supporting chamfered wood beams in the garage area.

Materials: Seven course common bond brick walls built on a concrete foundation. The roof has slate shingles. Door on first floor is wood and brick; garage door is wood. Window sills are masonry. Columns are cast iron with wood beams.

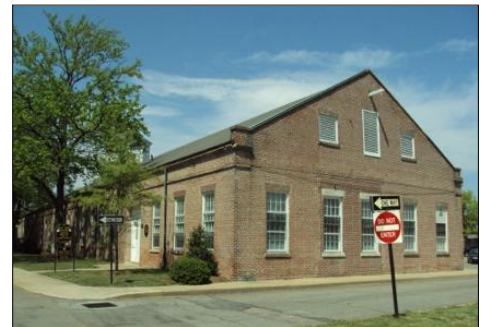
Building #: 27 and 27A**Built:** 1860**Address:** 66 Ingalls Road**Dimensions:** 236' 3" (twenty-three bays) x 52' 2"**Stories:** 1.0**NHL Status:** Contributing**Type:** Administrative**VA State Inventory #:** 114-0002-0138 and 114-0002-0139

Description: Building 27A is a rectangular floor plan and a subsidiary to building 27. The entrance is adorned with a masonry jack arch with a keystone. Windows are twelve-over-twelve-light double-hung sash. Building 27 has a T-shaped floor plan. The roof is side gabled, with an octagonal searchlight tower, added in 1904, at the roof ridge joint of the two rectangular blocks. The searchlight tower has eight-light double-hung sash windows. There is a full entablature, parapet and two interior chimneys. **First Floor:** Three entries with glazed paneled double doors, each with a stoop, painted jack arch and keystone. Windows are twelve-over-twelve-light double-hung sash with painted sills and lintels. **Interior:** (27) Some historical paneling at the north end on the wall and ceiling; some cast iron heat registers, some historic doors and transoms remain.

Materials: Masonry walls with three course English brick bond veneer built on a stone foundation. All roofs are asphalt shingles. Entry doors are wood, the masonry stoop, jack arch and window sills are all masonry. There is a brick splash course. The searchlight tower has wood clapboard. Building 27A has five course common bond brick walls built on a stone foundation.

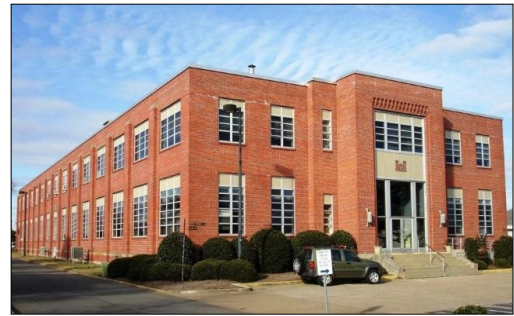
Building #: 28**Built:** 1939**Address:** 318 Cornog Lane**Dimensions:** 33' (seven-bay front) x 263' (fifteen-bay front)**Stories:** 2.0**NHL Status:** Contributing**Type:** Administrative**VA State Inventory #:** 114-0002-0140

Description: U-shape floor plan with a projecting central entrance bay with a built-up roof. The east and west facades have regularly spaced buttresses with coping. **First Floor:** Double door surrounded by five large plate glass windows in protecting bay; four-light and multi-paned jalousie windows. **Second Floor:** Jalousie windows. **Interior:** Open original bays and loading area with submarine mine depot on ground floor; original main stairs; original two-story entry vestibule; large metal vault on the second floor; some tracks are still visible.

Materials: Seven course common bond brick walls built on a concrete foundation and a brick water table with a concrete splash course. Roof parapet is aluminum; first floor door is aluminum and glass. Steps and coping are concrete. There are brick machicolations above second floor windows in projecting bays.

Mechanical/Electrical Systems: **Electrical:** Services from exterior transformer to an exterior disconnect switch and circuit breaker. **Mechanical:** A gas boiler; chiller; central AC system and sixteen AC window units. Gas-fired water heater.

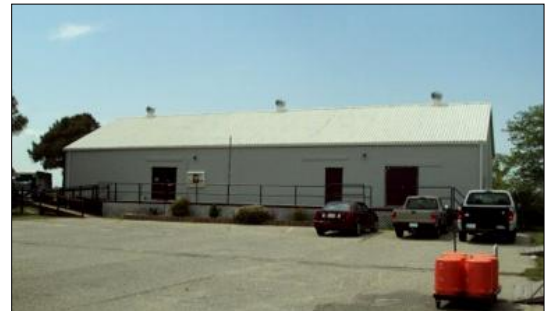
Building #: 32**Built:** 1934**Address:** 501 Fenwick Road**Dimensions:** 92' 4" (three-bay front) x 38' 3"**Stories:** 1.0**NHL Status:** Non-contributing**Type:** Administrative**VA State Inventory #:** 114-0002-0193

Description: Rectangular floor plan with a gabled roof.

Materials: Structural tile with stucco walls built on a concrete foundation, with a corrugated metal roof. There is a concrete loading platform along most of the façade with metal pipe railing; exposed roof rafters. There are two single metal doors and one solid metal door.

Mechanical/Electrical Systems: **Electrical:** Exterior transformers to an exterior disconnect switch and circuit breaker. **Mechanical:** Gas-fired water heater.

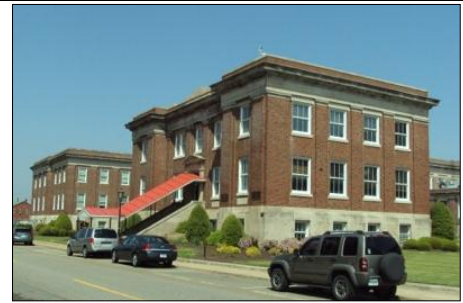
Building #: 37**Built:** 1934**Address:** 7 Fenwick Road**Dimensions:** 39' 4" (five-bay front) x 36'**Stories:** 2.0**NHL Status:** Contributing**Type:** Administrative**VA State Inventory #:** 114-0002-00141

Description: Rectangular floor plan with a symmetrical façade, a raised basement and built-up flat roof. A canopy (constructed in 1962) extends from the front entrance down to the sidewalk. The pedimented entrance has flanking pilasters and dentils. Windows are three-over-three-light double-hung sash with jack arches and sills.

Basement: Recessed three-over-three-light double-hung sash windows. **First Floor:** A central entry with paired glazed panel doors with one light. **Interior:** Original stairs and some doors, transoms and casings.

Materials: The walls are a limestone and Flemish bond built on a concrete foundation. Main entry door is wood; window sills are limestone. Exterior stairs are flanked by a solid masonry balustrade. There are limestone entablatures, brick pilasters, a pedimented limestone entrance, limestone panels below the first floor windows and a limestone water table.

Mechanical/Electrical: **Electrical:** Services from exterior transformer to an exterior disconnect switch and circuit breaker. **Mechanical:** A chiller and central AC system. Gas-fired water heater.

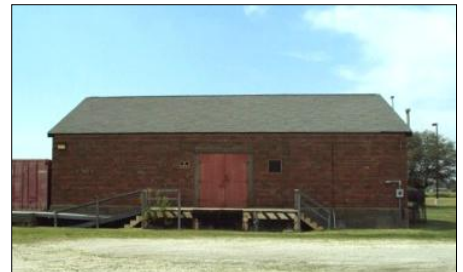
Building #: 38**Built:** 1934**Address:** 505 Fenwick Road**Dimensions:** 56' 6" (one-bay front) x 38' 3"**Stories:** 1.0**NHL Status:** Contributing**Type:** Administrative**VA State Inventory #:** 114-0002-0142

Description: Rectangular floor plan with a gabled roof and loading platform along most of the façade.

Materials: Exterior walls are constructed of structural tile on a concrete foundation, the roof has asphalt shingles, the loading platform is concrete and the door is metal.

Mechanical/Electrical Systems: **Electrical:** – Exterior transformers to an exterior disconnect switch and circuit breaker. **Mechanical:** Gas furnace, no AC.

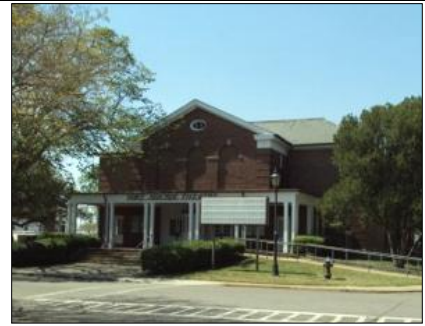
Building #: 42**Built:** 1938**Address:** 41 Tidball Road**Dimensions:** 114' 5" (three-bay front) x 72' 11"**Stories:** 2.0**NHL Status:** Contributing**Type:** Administrative**VA State Inventory #:** 114-0002-0143

Description: Rectangular floor plan with a symmetrical façade, front extension and hipped roof. There is a one story extended porch with a flat roof. The front extension has entablature and gable returns, a three-light oval window in the gable, three round arches in the center of the façade with keystones, brick quoins and quoin buttresses on the sides. Decorative trim is at the top of the ticket booth. **First Floor:** Two central entries with paired doors on both side of ticket booth; glazed paneled doors flank the vestibules; the ticket booth has four-light fixed windows. **Interior:** Many original architectural features remain.

Materials: Six course common bond brick walls built on a concrete foundation and water table. Roof has slate shingles. Entry doors are glass, the porch is a wooden frame with a paired wooden pier to support the roof.

Mechanical/Electrical Systems: **Electrical:** Exterior transformers to an exterior disconnect switch and circuit breaker. **Mechanical:** Gas boiler, chiller and central AC system. Gas-fired water heater.

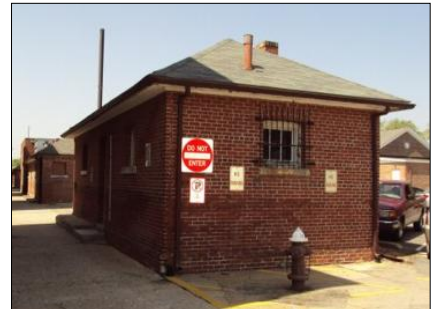
Building #: 46**Built:** 1901**Address:** 5 Bernard Road**Dimensions:** 53' 2" (three-bay front) x 16' 2"**Stories:** 1.0**NHL Status:** Contributing**Type:** Administrative**VA State Inventory #:** 114-0002-0145

Description: Rectangular floor plan with a hipped roof. **First Floor:** Raised panel door with a jack arch and transom. Six light sash windows with jack arches and sills. There is a chimney flue and overhanging eaves.

Materials: Five course common bond brick walls built on a concrete foundation. Asphalt roof shingles. Window sills are concrete; there is a brick water table and one course of projecting brick at the cornice.

Mechanical/Electrical Systems: **Electrical:** Exterior transformers to an exterior disconnect switch and circuit breaker. **Mechanical:** No HVAC system.

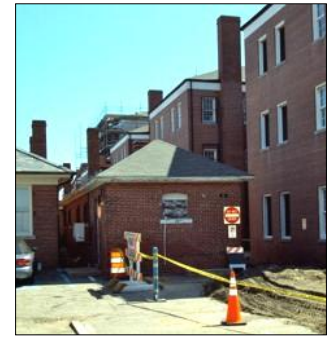
Building #: 47**Built:** 1901**Address:** 3B Bernard Road**Dimensions:** 16' 1" (three-bay front) x 68' 5"**Stories:** 1.0**NHL Status:** Contributing**Type:** Administrative**VA State Inventory #:** 114-0002-0144

Description: Rectangular floor plan with a hipped roof and two chimneys. The main façade originally faced south, the main entrance is now on the west side. **First Floor:** Main entrance has a jack arch and fixed one-light overlight. There are six-light fixed windows with jack arches and sills.

Materials: Five course common bond brick walls built on a concrete foundation. Asphalt roof shingles. The main door is of modern steel and there is a low brick water table.

Mechanical/Electrical Systems: **Electrical:** Exterior transformers to an exterior disconnect switch and circuit breaker. **Mechanical:** Heat pump, central AC system. Gas-fired water heater.

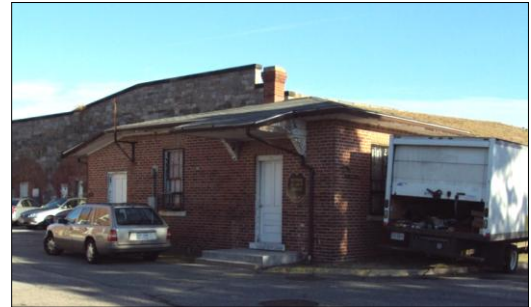
Building # 49**Built:** 1909**Address:** 184 Bernard Road**Dimensions:** 31' 9" (three-bay façade) x 17' 2"**Stories:** 1.0**NHL Status:** Contributing**Type:** Administrative**VA State Inventory #:** 114-0002-0146

Description: Rectangular floor plan with a side ell; hipped roof and central chimney with a wide soffit. **First Floor:** Raised panel, six-light door with a door hood and sawn brackets. Windows are six-over-six light double-hung sash with jack arches. **Interior:** Historic light fixtures; beaded tongue-and-groove trim in wing.

Material: Five course common bond brick walls built on a concrete foundation. The roof has asphalt shingles and a small square brick chimney flue with a corbelled cap.

Mechanical/Electrical Systems: **Electrical:** Exterior transformers to an exterior disconnect switch and circuit breaker. **Mechanical:** Electrical base board and window AC units. Gas-fired water heater.

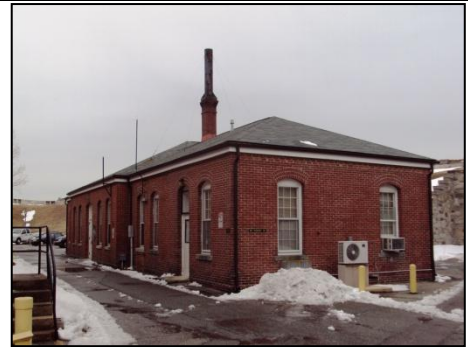
Building # 53**Built:** 1904**Address:** 188 Bernard Road**Dimensions:** 84' 1" (eleven-bay front) x 38' 4"**Stories:** 1.0**NHL Status:** Contributing**Type:** Administrative**VA State Inventory #:** 114-0002-0147

Description: Three-part façade with a real ell, an off-center central block and a hipped roof. **First Floor:** A contemporary raised panel double door with two fixed, one-light overlights and segmental arch. Windows are nine-over-nine light double-hung sash with segmental arches and sills.

Material: Stretcher bond brick walls built on a concrete foundation. The roof has asphalt shingles. Window sills are limestone. There is a low brick water table, a small brick central chimney flue with a corbelled cap and one row of brick headers at the cornice.

Mechanical/Electrical Systems: **Electrical:** Exterior transformers to an exterior disconnect switch and circuit breaker. **Mechanical:** A gas boiler, AC window units and a central AC system. Gas-fired water heater.

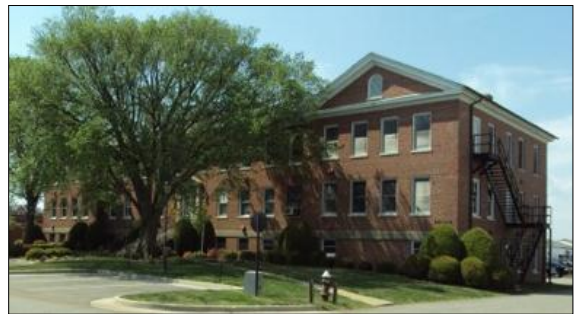
Building #: 56**Built:** 1939**Address:** 55 Patch Road**Dimensions:** 78' (seventeen-bay front) x 36'**Stories:** 2.0**NHL Status:** Contributing**Type:** Administrative**VA State Inventory #:** 114-0002-0148

Description: Rectangular floor plan with a symmetrical façade, raised basement, cross gabled roof and a pedimented entranceway with flanking pilasters. The front gabled roof dormers are pedimented with arch louvers. First and second floor windows are one-over-one light double-hung sash with sills. **Basement:** Windows are one-over-one light double-hung sash with sills. **First Floor:** A central entry with paired glazed doors. **Interior:** Original stair with steel pipe railing.

Materials: Five course common bond brick walls built on a concrete foundation. Roof has slate shingles. Window sills, a belt course and entrances are limestone. Stair railing is steel.

Mechanical/Electrical Systems: **Electrical:** Services from exterior transformer to an exterior disconnect switch and circuit breaker. **Mechanical:** A chiller, gas furnace and central AC system. Gas-fired water heater.

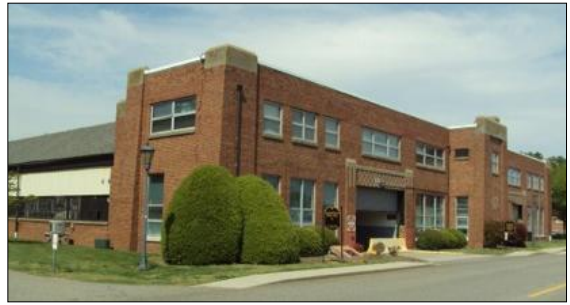
Building #: 57**Built:** 1934**Address:** 57 Patch Road**Dimensions:** 154' 0" (eleven-bay front) x 283' 0"**Stories:** 2.0**NHL Status:** Contributing**Type:** Administrative**VA State Inventory #:** 114-0002-0149

Description: Rectangular floor plan with a symmetrical façade. It is a two story front with a one story garage. There is an end chimney, a front center pylon extension, pylons at the corner of the building and buttresses that flank the garage doors. Both floors have jalousie windows with sills and lintels. **First Floor:** Central entry with glazed wood-paneled door and two overhead garage doors.

Materials: Five course common bond brick walls built on a concrete foundation. Asphalt roof shingles. Windows have metal frames with concrete sills and brick lintels. There is decorative concrete tile set in the walls.

Mechanical/Electrical Systems: This building has a wet fire suppression system. **Electrical:** Exterior transformers to an exterior disconnect switch and circuit breaker. **Mechanical:** Gas boiler and radiator; central AC system. Gas-fired water heater.

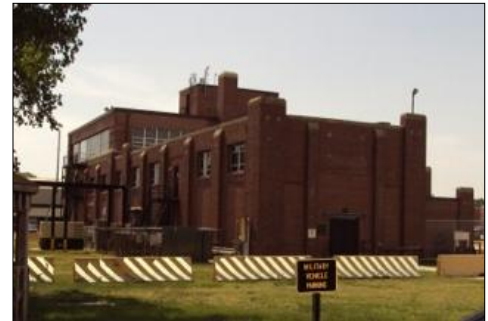
Building #: 59**Built:** 1934**Address:** 59 Patch Road**Dimensions:** 35' 4" (two-bay front) x 85' 4"**Stories:** 3.0**NHL Status:** Contributing**Type:** Administrative**VA State Inventory #:** 114-0002-0150

Description: The building raised two or three stories depending on the section. The roof is a built-up system. **First Floor:** Glazed door. **Third Floor:** Jalousie windows.

Materials: Five course common bond brick walls built on a concrete foundation. The first floor door is metal and the jalousie windows have metal frames. There are brick stringcourses and buttresses; concrete decorative panels and water table.

Mechanical/Electrical Systems: This building has a dry fire suppression system. **Electrical:** Exterior transformers to an exterior disconnect switch and circuit breaker. **Mechanical:** A gas boiler, chiller and central AC system. Six internal condensers installed for computer systems. Gas-fired water heater.

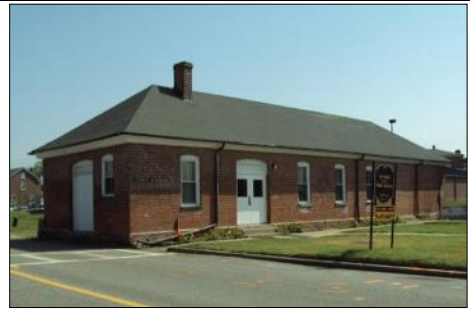
Building #: 73**Built:** 1893**Address:** 1 Fenwick Road**Dimensions:** 77' 9" (seven-bay front) x 22' 4"**Stories:** 1.0**NHL Status:** Contributing**Type:** Administrative**VA State Inventory #:** 114-0002-0151

Description: Rectangular floor plan with a hipped roof. There is one interior chimney. First Floor: Glazed paneled doors with segmental arches; 6 painted transoms; a bricked doorway with segmental arch. There are several bricked windows and one bricked doorway, the remaining windows are two-over-two light double-hung with jack arches and sills.

Materials: Five course common bond brick walls built on a concrete foundation. The roof has asphalt shingles. Window sills are concrete.

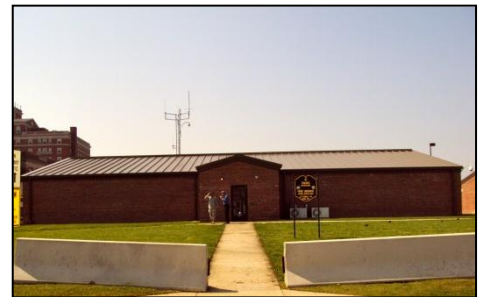
Description: Rectangular plan with a gable roof and a protruding center front gable portico. Explosion proof windows and doors which comply with post September 11, 2001 Army construction requirements.

Materials: Brick veneer walls built on a concrete foundation with a standing seam metal roof.

Mechanical/Electrical Systems: Building 246 has a wet fire suppression system. Needs to be verified.

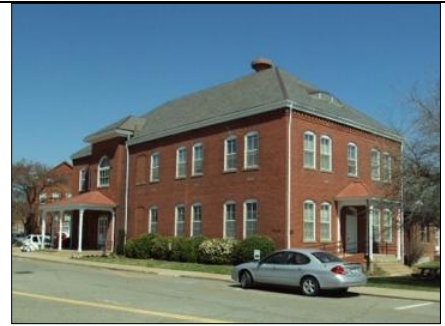
Building # 77**Built:** 1894**Address:** 3 Ruckman Road**Dimensions:** 89' 5" (nine-bay front) x 44' 2"**Stories:** 2.0**NHL Status:** Contributing**Type:** Administrative**VA State Inventory #:** 114-0002-0152

Description: Rectangular floor plan with an asymmetrical façade, partial-façade front porch and hipped roof. The porch has chamfered supports. There is a hipped wall dormer that extends out in the front, louvered eyebrow dormers and wide soffits. Both floors have four-over-four light double-hung sash windows with segmental arches and sills. **First Floor:** Paired, paneled glazed doors with a lintel and step. **Interior:** Original stair with handrail, turned balusters and molded newels; historic triangle; original floor plan is intact.

Material: Five course common bond brick walls built on a concrete foundation with a brick and concrete water table. The roof has asphalt shingles, brick dentils under the main roof cornice and a metal ridge with end knobs. First floor doors have a stone lintel and step. Window sills are concrete. The porch is a wooden frame with metal railing, a metal hipped roof and a concrete foundation. The interior stair handrails are oak with a steel triangle bolted to the stair stringer. The doorway, fanlight and some windows are bricked. There is a single brick chimney.

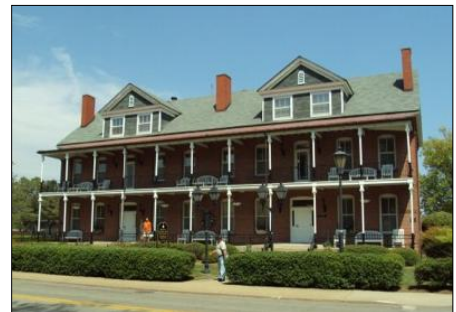
Building # 80**Built:** 1897**Address:** 80 Ingalls Road**Dimensions:** 87' 4" (ten-bay front) x 32' 7"**Stories:** 2.5**NHL Status:** Contributing**Type:** Administrative**VA State Inventory #:** 114-0002-0153

Description: Two, five-bay buildings sharing a common roof and wall. A rectangular floor plan, symmetrical façade and full façade front porch. A side gabled roof, each dormer has three-over-three-light double-hung sash windows. There are four chimneys (two interior, two central); two gabled dormers each with a rounded arch louvered window. Windows on the first and second floor are two-over-two-light double-hung sash with segmental arches. Both floors have two paneled glazed doors with one light transom. There are rosettes under the porch cornice. **Interior:** The north end of the building features original stairs with square balusters, fireplace mantel, doors and trim. South end features fireplace mantels with mottled brown and white ceramic tile, mantel shelves and beveled mirrors; stairs have turned balusters and chamfered newel posts.

Material: Stretcher bond brick walls built on a concrete foundation. The roof has asphalt shingles. The porch has a wooden frame with cast iron supports, a hipped tin roof (no pitch) and a brick foundation. The dentils under the cornices are break headers.

Mechanical/Electrical System: This building has a wet fire suppression system. **Electrical:** Exterior transformers to an exterior disconnect switch and circuit breaker. **Mechanical:** A gas boiler, chiller and central AC system. Gas-fired water heater.

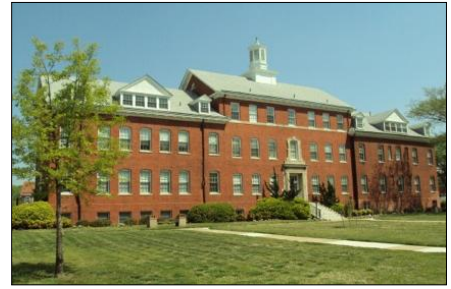
Building #: 82**Built:** 1898**Address:** 60 Ingalls Road**Dimensions:** 176' 5" (twenty-one bay front) x 31' 5"**Stories:** 3.0**NHL Status:** Contributing**Type:** Administrative**VA State Inventory #:** 114-0002-0154

Description: Front facing H-plan with two story side wings, a raised basement and side gabled roof. There is an octagonal, louvered copula; pilasters and entablature at each entrance extending upwards to encompass a second floor window. Each wing has a four window gable dormers, flanked by one-window gable dormers. Windows are six-over-six-light double-hung sash with segmental arches and sills. The south side has two-over-two light casement windows. The gabled dormers have six-over-six light double hung sash windows. The north wing was extended in 1904, Building 162 was connected in 1912, enlarged on the south side in 1913, and 1941 the roof was raised and extended. Basement: Three-over-three light casement windows. First Floor: Paired doors with four-light transom set in casing. Interior: Historic vestibule in main entry; two sets of stairs at each end of the building.

Materials: Stretcher bond brick walls with red mortar built on concrete foundations and asphalt shingled roof. Door casings are limestone; window sills are stone and window dormers have asphalt siding. The second floor has limestone casing around the window over main entrance. The copula has a metal roof. Two sets of steel stairs.

Mechanical/Electrical System: The rear has a dry, while the front has a wet fire suppression system. Electrical: Exterior transformers to an exterior disconnect switch and circuit breaker. Mechanical: A gas boiler, two chillers and central AC system. Gas-fired water heater.

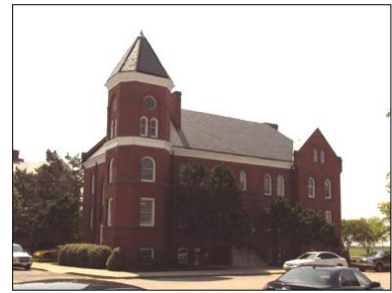
Building #: 83**Built:** 1898**Address:** 20 Ingalls Road**Dimensions:** 45' 0" (eight bay front) x 37' 0"**Stories:** 2.0 (clock tower is 3 stories)**NHL Status:** Contributing**Type:** Administrative**VA State Inventory #:** 114-0002-0155

Description: Rectangular floor plan with an asymmetrical façade, a raised basement, three chimneys and a cross-gabled roof. The clock tower is in a recessed arch; the porch has an entry vestibule with doors on either side; dentilled cornices. The south side extends frontally with a parapeted gable, moldings and louvered windows. In 1953 the interior was remodeled, loading docks were added in 1959, fire escapes 1970 and mail room enlarged.

Basement: Four-over-four-light double-hung sash windows. **First Floor:** Central entry with telescoping archway and one-over-one-light double-hung sash windows with jack arches and sills. **Second Floor:** One-over-one-light double-hung sash windows with round arches. **Interior:** Some original door casings and transoms.

Materials: Stretcher bond brick walls with red mortar built on a concrete foundation; slate roofs; brick water table. Second floor windows have stone sills with brick hoodmolds. The clock is set in concrete and brick belt courses. Moldings are terra cotta, decorative terra cotta disks/trim extend around the entranceway. **Interior:** Original oak trimmed vestibule with bronze boxes and grilles, and pressed tin ceiling. Flooring is original wood.

Mechanical: A gas boiler, chiller, and central AC system. Gas-fired water heater.

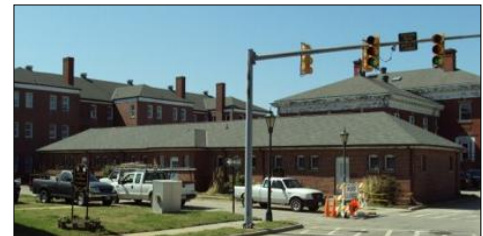
Building #: 84**Built:** 1898**Address:** 1 Bernard Road**Dimensions:** 112' 9" (twenty-two bay front) x 23' 7"**Stories:** 1.0**NHL Status:** Contributing**Type:** Administrative**VA State Inventory #:** 114-0002-0156

Description: Rectangular floor plan with three rear wings, an extended front and a hipped roof (with a center extension). **First Floor:** Paneled glazed doors with jack arches. There are two-over-two-light double-hung sash windows and two-over-two-light casement windows with jack arches and sills. Converted 1842, rear wings were added 1901 and remodeled in 1970.

Building: Five course common bond brick walls built on a concrete foundation. Roof has asphalt shingles. Windows have concrete sills. There are raised brick friezes and a brick water table.

Mechanical/Electrical Systems: **Electrical:** Exterior transformers to an exterior disconnect switch and circuit breaker. **Mechanical:** A gas boiler; central AC system. Gas-fired water heater

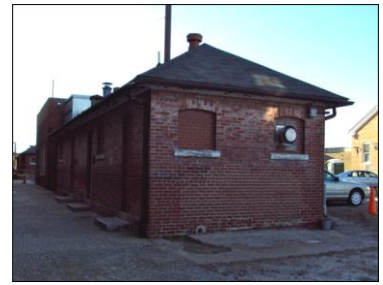
Building #: 85**Built:** 1898**Address:** 5 Bernard Road**Dimensions:** 56' 1" (five-bay front) x 16' 0"**Stories:** 1.0**NHL Status:** Contributing**Type:** Administrative**VA State Inventory #:** 114-0002-0157

Description: Rectangular floor plan with symmetrical façade and a hipped roof. First Floor: Paneled doors with jack arches. Windows have been bricked or otherwise filled and have jack arches.

Materials: Five course common brick walls built on a concrete foundation. The roof has asphalt shingles. Doors are wood, windows have concrete sills and there are bricked windows with jack arches.

Mechanical/Electrical Systems: Electrical: Exterior transformers to an exterior disconnect switch and circuit breaker. Mechanical: The building is equipped with a 2-ton condenser to provide heat and air conditioning to Building 5. Gas-fired water heater.

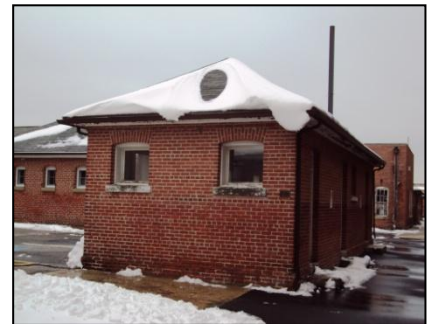
Building #: 86**Built:** 1898**Address:** 2 North Gate Road**Dimensions:** 46' 1" (four-bay front) x 16' 0"**Stories:** 1.0**NHL Status:** Contributing**Type:** Administrative**VA State Inventory #:** 114-0002-0158

Description: Rectangular floor plan with symmetrical façade with a hipped roof. First Floor: Glazed panel doors with jack arches, there are single paned casement windows with jack arches and sills.

Materials: Five course common brick walls built on a concrete foundation with a raised brick friezes and brick water table. Asphalt shingle roof; concrete window sills; and wood doors.

Mechanical/Electrical Systems: Electrical: Exterior transformers to an exterior disconnect switch and circuit breaker. Mechanical: No HVAC system, only one AC window unit. Gas-fired water heater.

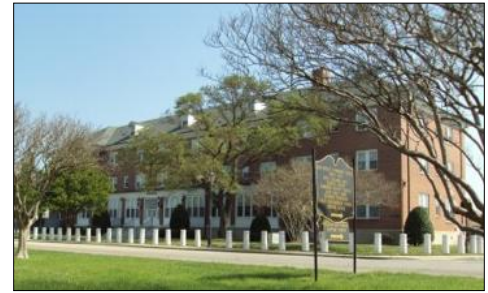
Building #: 87**Built:** 1932**Address:** 150 Ingalls Road**Dimensions:** 104' 0" (fifteen-bay front) x 42' 0"**Stories:** 3.0**NHL Status:** Contributing**Type:** Administrative**VA State Inventory #:** 114-0002-0159

Description: Rectangular floor plan with symmetrical façade, raised basement and two chimneys. The roof is cross-hipped; windows are nine-over-nine-light double-hung sash. There are pedimented dormers with six-over-six-light double-hung sash windows. The porch is one story and a partial façade. It has nine bays and a flat roof.

First Floor: Three central entries; paired glazed paneled doors with sidelights and transoms. **Interior:** Original stairs with railing and original terrazzo flooring on ground floor corridors.

Materials: Five course common brick walls built on a concrete foundation. The roof and dormers have asphalt shingles; there is a concrete water table; and the porch has a wood entablature, brick pilasters with concrete capitals and bases. The stair railing is steel.

Mechanical/Electrical Systems: This building has a wet fire suppression system. **Electrical:** Exterior transformers to an exterior disconnect switch and circuit breaker. **Mechanical:** A gas boiler, chiller and central AC system. Gas-fired water heater.

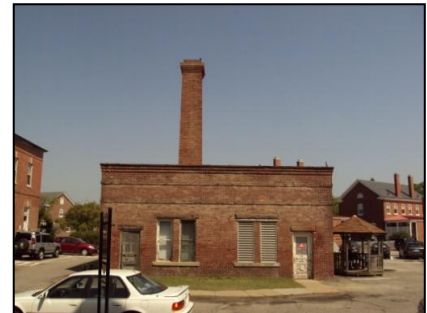
Building #: 92**Built:** 1897**Address:** 15 Whistler Lane**Dimensions:** 38' 3" (six-bay front) x 31' 9"**Stories:** 1.0**NHL Status:** Contributing**Type:** Administrative**VA State Inventory #:** 114-0002-0160

Description: Rectangular plan with a built-up flat roof. There is a central chimney with a corbelled cap and cornice. **First Floor:** Paneled glazed doors, one-over-one-light double-hung sash windows.

Materials: Five course common bond brick walls built on a concrete foundation. The doors are wood; window sills are concrete with stone lintels. There is a brick string course and corbelled cornice.

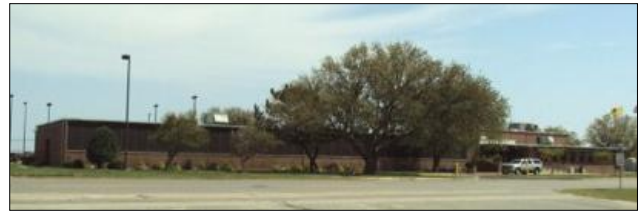
Building #: 96**Built:** 1958**Address:** 380 Fenwick Road**Dimensions:****Stories:** 1.0**NHL Status:** Non-contributing**Type:** Administrative**VA State Inventory #:** 114-0002-0207

Description: Asymmetrical façade with a built-up flat roof and one chimney. **First Floor:** Four central doors with two lights; ribbon widows; sixteen-over-one-light casement windows, upper part has sixteen opaque glass panels; and one-over-one-light double-hung sash windows.

Materials: Five course common bond brick walls built on a concrete foundation. There is a wooden door frame.

Mechanical/Electrical System: **Electrical:** Exterior transformers to an exterior disconnect switch and circuit breaker. **Mechanical:** Gas-fired water heater.

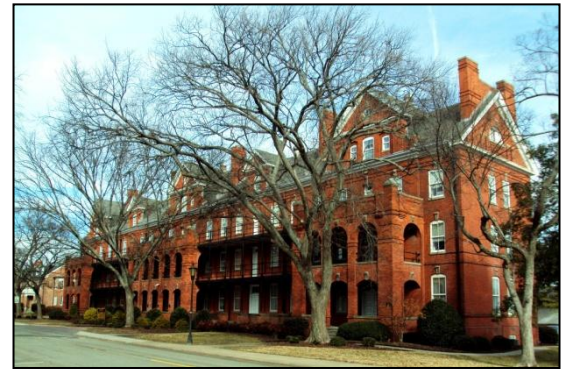
Building #: 100**Built:** 1897**Address:** 90 Ingalls Road**Dimensions:** 225' 2" (ten-bay front) x 34' 3"**Stories:** 3.5**NHL Status:** Contributing**Type:** Administrative**VA State Inventory #:** 114-0002-0161

Description: Rectangular floor plan; eight chimneys; a raised basement; front stair towers and rear ells. Roof is gabled with three large dormers: each with six-over-six-light double hung sash windows, segmental arches and decorative keystones; flanked by two recessed two-over-two-light double-hung sash windows, segmental arches, decorative keystones; a round window with a keystone in tympanum. Two smaller gable-roof dormers have six-over-six-light double hung sash windows with decorative keystones. At the pedimented gable ends there are half rounded windows with segmental arches above the windows on the side and rear elevations. Remaining windows are two-over-two-light double hung sash with jack arches and sills. There are three two-story, two level porch/stair towers with arched opening, decorative keystones and sills. The central porch has five bays, the remaining have three bays. **First Floor:** Five doorways with raised panel doors and three light transoms. **Second and Third Floor:** Single raised panel doors.

Materials: Stretcher bond brick walls built on a concrete foundation. There is a brick water table; string course at the second floor and below the cornice on the gable ends; double string course at the third; asphalt shingles on roof; masonry window sills. Porch/stair towers have low brick walls, masonry sills and coping. The infill stair towers have brick piers, concrete slab floors and metal pipe railing.

Mechanical/Electrical Systems: This building has both a wet and dry fire suppression system. **Electrical:** Exterior transformers to an exterior disconnect switch and circuit breaker. **Mechanical:** One heat pump, chiller and central AC system. Gas-fired water heater.

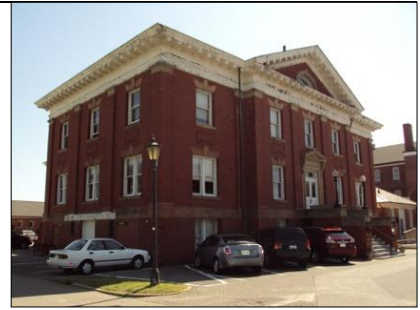
Building #: 105**Built:** 1905**Address:** 3 Bernard Road**Dimensions:** 93' 0" (five-bay front) x 43' 0" plus 19' 0" x 45' 0"**Stories:** 2.0**NHL Status:** Contributing**Type:** Administrative**VA State Inventory #:** 114-0002-0162

Description: T-shape floor plan with a projecting central block and a hipped roof with a cross gable. The building has a raised basement, full entablature, raking cornice and arched opening on stair landing. Windows are one-over-one-light double-hung sash with jack arches, keystones and sills. There are two chimneys and a half round window at the cross gable. **First Floor:** Pedimented doorway supported by consoles, a glazed one-light double door and a fixed one-light overlight. End windows are paired. **Interior:** Broad entry hall featuring a double stair with turned oak balusters and a molded handrail. The ceiling has pressed tin plates featuring large central medallions. There are original: pipe railings on the second floor mezzanine; wood base, chair moldings, picture moldings, window and doors casings; five paneled doors and transoms. The vestibule paneling and one-over-one wood double-hung window sash appears to be original.

Materials: Stretcher bond brick walls built on a concrete foundation. The roof has asphalt shingles. Window arches, keystones and sills are limestone. The building has a concrete splash course, brick pilasters with concrete caps on the façade, brick panels in the walls between the floors, pink mortar and a brick tympanum. The chimneys have decorative brickwork in the caps; there are granite steps with limestone coping. The interior ceiling has pressed tin plates; there are wooden columns and pilasters, and original pipe railings.

Mechanical/Electrical System: **Electrical:** Exterior transformers to an exterior disconnect switch and circuit breaker. **Mechanical:** A gas boiler, chiller and central AC system. Gas-fired water heater.

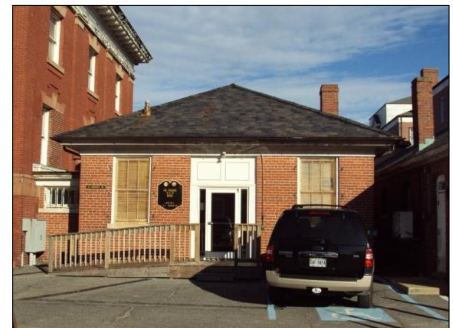
Building #: 105A**Built:** 1909**Address:** 3 Bernard Road**Dimensions:** 28' 0" (three-bay front) x 71' 4"**Stories:** 1.0**NHL Status:** Contributing**Type:** Administrative**VA State Inventory #:** 114-0002-0163

Description: Rectangular floor plan attached to Building # 105 by a small transitional block. The roof is hipped with wide overhanging eaves and a central chimney. **First Floor:** Double doors with six-light overlight and three-over-three-light double-hung sash windows with sills.

Materials: Five course common bond walls built on a concrete and brick foundation. The roof has slate shingles. Window sills are limestone; doors are aluminum.

Mechanical/Electrical System: **Electrical:** Exterior transformers to an exterior disconnect switch and circuit breaker. **Mechanical:** Gas boiler, chiller and central AC system. Gas-fired water heater.

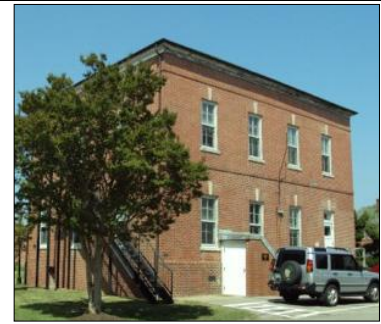
Building #: 116**Built:** 1906**Address:** 30 Harrison Street**Dimensions:** 38' 0" (three-bay front) x 45' 6"**Stories:** 2.0**NHL Status:** Contributing**Type:** Administrative**VA State Inventory #:** 114-0002-0164

Description: Rectangular floor plan, hipped roof, raised basement and a central chimney. Windows on both floors are four-over-four-light double-hung sash with jack arches, keystones, voussoirs and sills. **First Floor:** Double raised panel doors with three-light overlight, jack arch and keystone.

Materials: Stretcher bond brick walls built on a concrete and brick foundation. Roof has asphalt shingles. First floor door has a brick arch with a limestone keystone. Windows have brick arches and limestone sills. There are granite steps with brick and granite trim. The chimney has limestone coping, there is a brick water table and a belt course above each floor.

Mechanical/Electrical System: This building has a dry fire suppression system. **Electrical:** Exterior transformers to an exterior disconnect switch and circuit breaker. **Mechanical:** HVAC supplied from Building 134. Gas-fired water heater.

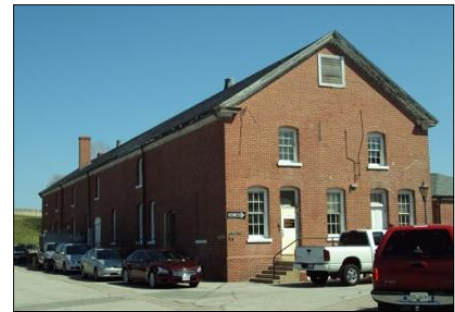
Building #: 117**Built:** 1906**Address:** 190 Bernard Street**Dimensions:** 36' 0" (five-bay front) x 152' 3"**Stories:** 2.0**NHL Status:** Contributing**Type:** Administrative**VA State Inventory #:** 114-0002-0165

Description: Rectangular floor plan with a front facing gable. There are three chimneys with a large exterior flue to the rear, returns at the eaves and a louvered opening in the front-facing gable. Windows are six-over-six-light double-hung sash windows with segmental arches. Exterior stairs and elevator were added in 1957, wooden porches were replaced in 1959. Some windows have been bricked up and there was a fire in 1930. **First Floor:** Two paneled doors with segmental arches. Window arches are made of three rows of headers.

Materials: Stretcher bond brick walls built on a brick and concrete foundation. The roof has asphalt shingles. There is a brick water table. Segmental arches are made of three rows of brick headers.

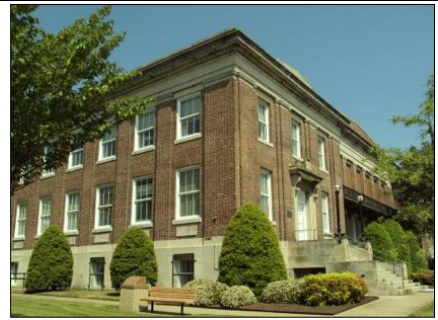
Building #: 133**Built:** 1909**Address:** 33 Ingalls Road**Dimensions:** 164' 0" (thirteen-bay front) x 118' 0"**Stories:** 2.0**NHL Status:** Contributing**Type:** Administrative**VA State Inventory #:** 114-0002-0166

Description: U-shaped floor plan with a recessed central block, a built-up roof, raised basement, pilasters and a dentilled cornice. Windows on both floors are three-over-three light double-hung sash. **First Floor:** Double doorway with a pediment supported by consoles and a coat-of-arms. Windows have jack arches. **Interior:** Two sets of original staircases; skylight over the stairs; ornamented columns.

Materials: Steel structural system with Flemish bond brick walls built on a cement foundation. First floor door pediment is limestone. First floor windows have limestone sills and brick arches. There are two sets of granite steps with limestone coping and a cast iron porch on the central block. Stone panels are under windows on the first floor. The columns are cast iron columns and there is some plaster ornamentation.

Mechanical/Electrical Systems: **Electrical:** Exterior transformers to an exterior disconnect switch and circuit breaker. **Mechanical:** Heat supplied from Building 134; central AC system. Gas-fired water heater.

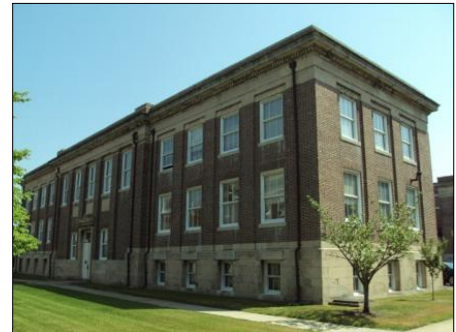
Building #: 134**Built:** 1909**Address:** 20 Whistler Lane**Dimensions:** 50' 0" (eleven-bay front) x 58' 6"**Stories:** 2.0**NHL Status:** Contributing**Type:** Administrative**VA State Inventory #:** 114-0002-0167

Description: T-plan with a central block that projects slightly and a raised basement. Flat roof covered with a built up system. There are pilasters on the central block along with a dentilled cornice. Windows on both floors are three-over-three-light double-hung with jack arches and sills. **First Floor:** A door with an egg and dart trim and pediment. There are double doors with recessed panels. **Interior:** Original stairs; some original doors, casings and transoms.

Materials: Flemish bond brick walls built on a concrete and brick foundation. The first floor has both a limestone and double wooden doors. Windows have limestone sills. The basement has a brick water table. The pilasters have limestone capitals and there are limestone panels between the floors and cornice.

Mechanical/Electrical Systems: **Electrical:** Exterior transformers to an exterior disconnect switch and circuit breaker. **Mechanical:** Oil/gas boiler, two chillers and central AC system. Gas-fired water heater.

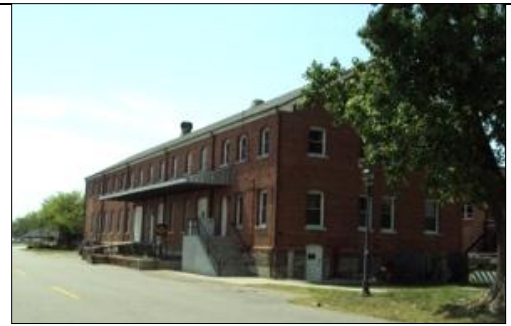
Building #: 135**Built:** 1908**Address:** 61 Patch Road**Dimensions:** 165' 0" (fifteen bay front) x 40' 9"**Stories:** 2.0**NHL Status:** Contributing**Type:** Administrative**VA State Inventory #:** 114-0002-0168

Description: Rectangular floor plan with a gabled roof. Windows are one-over-one-light double-hung sash with segmental arches made of three rows of headers. The pent roof has I-beams. **First Floor:** Three double doors with diagonal car siding; three single doors with diagonal car sliding and two solid modern doors. **Interior:** Historic freight elevator and some ornamental heating grills.

Materials: Five course common bond brick walls built on a stone foundation; a brick water table and concrete splash course. Asphalt roof shingles with the pent roof having corrugated metal. There are iron tie rods.

Mechanical/Electrical System: This building has a dry fire suppression system. **Electrical:** Exterior transformers to an exterior disconnect switch and circuit breaker. **Mechanical:** Oil boiler and central AC systems. Gas-fired water heater.

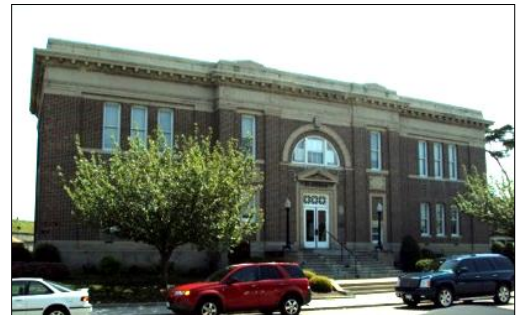
Building #: 138**Built:** 1909**Address:** 30 Ingalls Road**Dimensions:** 102' 5" (five-bay front) x 35' 0"**Stories:** 2.0**NHL Status:** Contributing**Type:** Administrative**VA State Inventory #:** 114-0002-0169

Description: T-plan shape with projecting central blocks, a raised basement and full entablatures. Flat roof covered with a built up system. Windows on both floors are one-over-one-light double-hung sash windows with jack arches and sills. **First Floor:** Double door with overlight; egg and dart molding, sculpted pediment and. **Second Floor:** Half-round windows with arches and decorative keystones, supported by pilasters. **Interior:** Original vestibule and molded plaster ornamentation in principle interior space.

Materials: Common bond brick walls with limestone trim built on a stone foundation. First floor has a limestone door. Windows have limestone sills. Windows on the second floor also have limestone arches and keystones. Exterior stairs are limestone and granite with case iron street lamps. The basement has a brick water table, brick pilasters with limestone caps, limestone panels in the wall between floors.

Mechanical/Electrical Systems: **Electrical:** Exterior transformers to an exterior disconnect switch and circuit breaker. **Mechanical:** Gas boiler, chiller and central AC duct system. Gas-fired water heater.

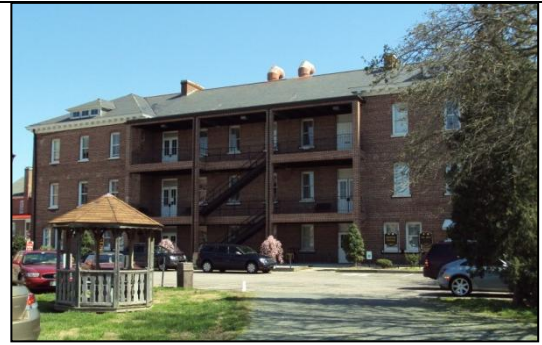
Building #: 139**Built:** 1909**Address:** 173 Bernard Road**Dimensions:** 60' 0" (eleven-bay front) x 40' 2"**Stories:** 3.5**NHL Status:** Contributing**Type:** Administrative**VA State Inventory #:** 114-0002-0170

Description: U-shaped floor plan with a recessed central block, a hipped roof and six chimneys. There are two hipped dormers with three two-light fixed sash windows and a three story, three bay porch/stair tower across the main façade with columns and spandrels. There is a modillioned cornice and a soldier course near the cornice on the side elevations. Windows for the entire building are two-over-two-light double-hung sash with jack arches and sills. **First Floor:** Two; glazed, four light, paneled doors with jack arches.

Materials: Five course common bond brick walls built on a stone foundation with a slate roof. Window sills are limestone. The porch columns and spandrels are brick with concrete slab floors and original steel stairs.

Mechanical/Electrical Systems: This building has a dry fire suppression system. Systems need to be verified.

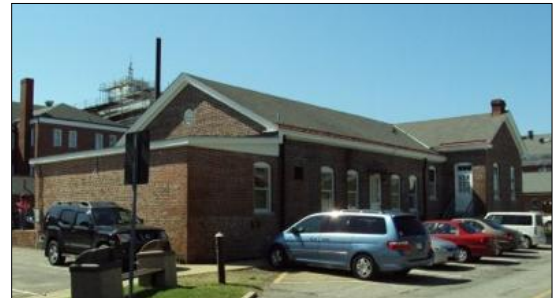
Building #: 159**Built:** 1911**Address:** 193 Bernard Road**Dimensions:** 32' 2" (five-bay front) x 85' 2" and 42' 0" x 46' 0"**Stories:** 1.0**NHL Status:** Contributing**Type:** Administrative**VA State Inventory #:** 114-0002-0171

Description: Rectangular floor plan with a rear wing and raised basement. Roof is gabled with a cross gable and an interior end chimney. **First Floor:** Solid double doors with transom (boarded up) and segmental arch made of three rows of headers. Windows are six-over-six-light double-hung sash with segmental arches, two rows of headers and sills.

Materials: Five course common bond brick walls built on a concrete foundation. Roof has asphalt shingles. Window sills are limestone. There are concrete steps, a brick water table and a limestone splash course.

Mechanical/Electrical Systems: **Electrical:** Exterior transformers to an exterior disconnect switch and circuit breaker. **Mechanical:** A heat pump and central AC system. Gas-fired water heater.

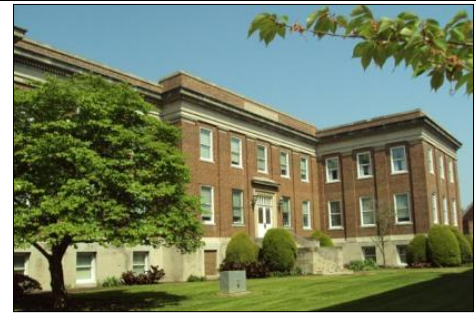
Building #: 161**Built:** 1912**Address:** 5 Fenwick Road**Dimensions:****NHL Status:** Contributing**Stories:** 2.0**Type:** Administrative**VA State Inventory #:** 114-0002-0172

Description: Five part plan with a raised basement and two chimneys. U-plan shape with two wings perpendicularly attached to a main volume. Windows are one-over-one-light double hung sash with jack arches and sills. Building size was doubled in 1938. **First Floor:** Two main doorways with double raised panel doors surrounded by a decorative door frame. **Interior:** Two original stairs.

Materials: Flemish bond brick walls built on a masonry foundation. Roof is a low pitched gable and a flat built up system. First Floor door frame is decorative limestone; window sills are limestone. There are granite steps with limestone coping, a limestone water table, brick pilasters with limestone caps and limestone panels near the cornice line.

Mechanical/Electrical Systems: This building has both a wet and dry fire suppression system. **Electrical:** Exterior transformers to an exterior disconnect switch and circuit breaker. **Mechanical:** Gas boiler, chiller; part of heating and AC systems are supplied from Building 134 and central AC system. Gas-fired water heater.

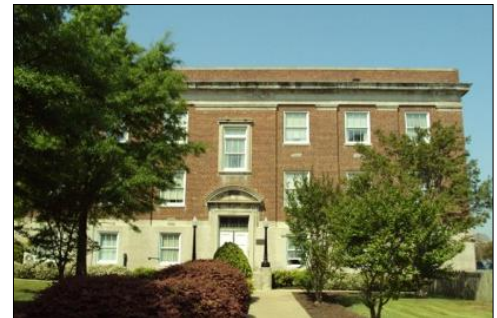
Building #: 163**Built:** 1940**Address:** 10 Whistler Lane**Dimensions:** 90' 7" (seven-bay front) x 55' 7"**Stories:** 2.0**NHL Status:** Contributing**Type:** Administrative**VA State Inventory #:** 114-0002-0173

Description: Rectangular floor plan with a flat built-up roof. Windows are three-over-three-light double-hung sash; there is a central window and a rounded pediment over the entrance. **First Floor:** Central entry with paired wood-paneled gazed doors. **Interior:** Original stair; some original doors, casings and transoms.

Materials: Flemish bond brick and stone walls built on a concrete and brick foundation. Window sills are stone. There is a stone entablature supported by full height brick pilasters with stone capitals and bases. The center window has stone casing. There are stone door casings and a metal grade over the transom.

Mechanical/Electrical Systems: **Electrical:** Exterior transformers to an exterior disconnect switch and an exterior circuit breaker. **Mechanical:** Gas boiler and central AC system. Gas-fired water heater.

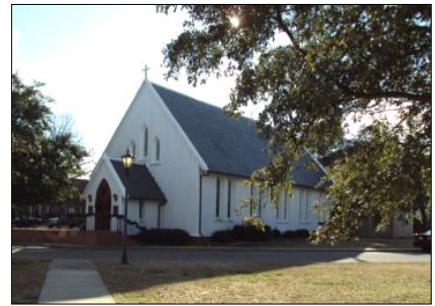
Building #: 166**Built:** 1857**Address:** 135 Bernard Road**Dimensions:** 30' 3" (three bays) x 68' 10"**Stories:** 1.0**NHL Status:** Contributing**Type:** Administrative (chapel)

Description: Rectangular floor plan with projecting vestibule, chancel and gabled roof. Crosses are mounted at each end of the roof ridge. **First Floor:** Central, double entry doors. **Second Floor:** There are a central group of three gothic-arched windows made of stained glass on the gabled end. **Interior:** Exposed roof trusses; a dominant aisle with two lesser aisles. Several memorial stained glass windows, some of which were prepared by the Tiffany Studios in New York City; original windows include the triple lancet windows over the vestibule and vestry.

Material: Wood frame with board and batten, built on a cement and brick foundation (which was added in 1968). The roof has slate shingles. Entry doors and crosses are wood. A wood ceiling is supported by pointed wood arches, plaster interior walls and a wood organ loft over the entry.

Mechanical/Electrical Systems: **Electrical:** Exterior transformers to an exterior disconnect switch and circuit breaker. **Mechanical:** Gas-fired water heater.

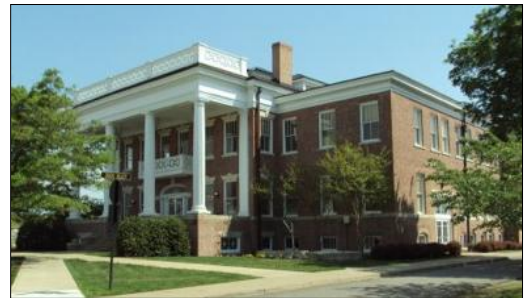
Building #: 171**Built:** 1907**Address:** 8 Ruckman Road**Dimensions:****Stories:** 2.5**NHL Status:** Contributing**Type:** Administrative**VA State Inventory #:** 114-0002-0174

Description: Rectangular floor plan built on a raised basement and two exterior chimneys with corbelled caps. The monumental central porch has six bays with full-height columns and square balusters. The roof is framed by a cornice-line balustrade. On the south side of the building there is a one-story exterior mezzanine with a decorative balustrade; while on the north there is a two and one half story masonry wing. Despite extensive renovations in 2002 the building retains many original architectural features. There are a variety of windows: one-over-one-light double-hung sash; four-over-four double-hung sash; four-light fixed; three-over-one-light double-hung sash; and union jack fixed. **First Floor:** Double glazed door with sidelights, elliptical fanlight and decorative keystone. **Second Floor:** A central two-bay cantilevered porch with decorative square balustrade.

Materials: Flemish Bond Brick walls built on a concrete foundation. Windows have limestone lintels and sills.

Mechanical/Electrical Systems: This building has a wet fire suppression system. **Electrical:** Exterior transformers to an exterior disconnect switch and circuit breaker. **Mechanical:** A gas boiler, chiller and central AC system. Gas-fired water heater.

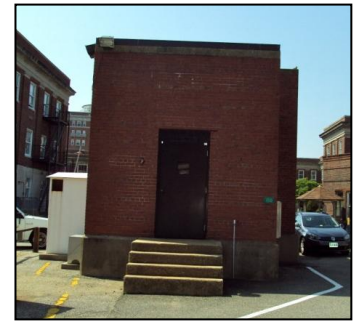
Building #: 180**Built:** 1942**Address:** Harrison Street**Dimensions:** 14' 2" (one-bay front) x 25' 9"**Stories:** 1.0**NHL Status:** Non-contributing**Type:** Administrative (Pump house)**VA State Inventory #:** 114-0002-0218

**Description:** Rectangular plan with a built-up roof and exterior end chimney. Entrance is through a glazed door.**Materials:** Five course common bond brick walls built on a concrete foundation; concrete steps and a metal door.**Mechanical/Electrical Systems:** Needs to be verified.**Building #: 182****Built:** 1945**Address:** 3 Moat Walk**Dimensions:** 46' 4" (five-bay front) x 43' 2"**Stories:** 1.0**NHL Status:** Contributing**Type:** Administrative**VA State Inventory #:** 114-0002-0175

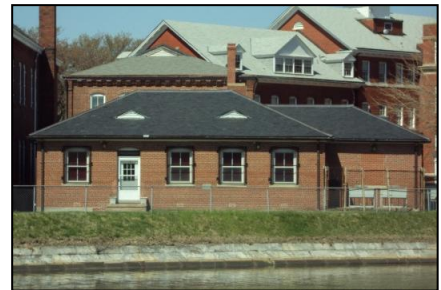
**Description:** Rectangular floor plan with a hipped roof and chimney. There are nine-light wood paneled doors; louvered eyebrow and two-over-two-light double-hung sash windows with segmental arches and concrete sills.**Building Materials:** Five course common bond brick walls built on a concrete foundation. Slate shingled roof.**Mechanical/Electrical Systems:** Electrical: Exterior transformers to an exterior disconnect switch and circuit breaker. Mechanical: Gas boiler and central AC duct system. Gas-fired water heater.**Building #: 183****Built:** 1945**Address:** 102 McNair**Dimensions:** 120' 2" (seven-bay front) x 43' 2"**Stories:** 1.0**NHL Status:** Contributing**Type:** Administrative**VA State Inventory #:** 114-0002-0176

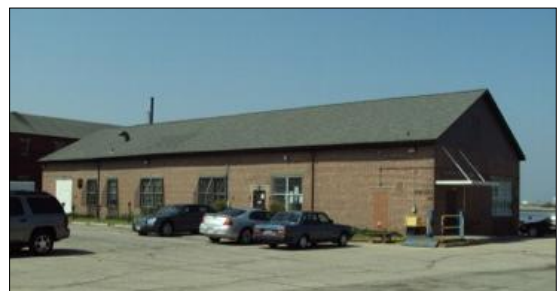
**Description:** Rectangular floor plan, with a side gabled roof. First Floor: Paneled door and overhead garage door and twelve-light casement windows.**Materials:** Five course common bond brick walls built on a concrete foundation. Roof has asphalt shingles. Main door is wood, garage door is metal.**Mechanical/Electrical Systems:** Electrical: Exterior transformers to an exterior disconnect switch and circuit breaker. Mechanical: Gas boiler and central AC system. Gas-fired water heater.

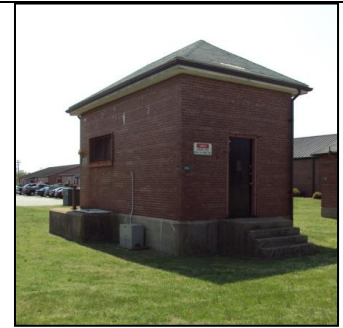
Building #: 184**Built:** 1942**Address:** 184 Fenwick Road**Dimensions:** 14' 6" (one-bay front) 26' 3"**Stories:** 1.0**NHL Status:** Non-contributing**Type:** Administrative (Pump house)**VA State Inventory #:** 114-0002-0219

**Description:** Rectangular plan with a hipped roof, one main door and an exterior end chimney.**Materials:** Five course common bond brick walls built on a concrete foundation, asphalt roof and a metal door.**Mechanical/Electrical Systems:** Needs to be verified.**Building #: 185****Built:** 1945**Address:** 490 Fenwick Road**Dimensions:** 209' 0" (ten-bay front) x 83' 6"**Stories:** 1.0**NHL Status:** Non-contributing**Type:** Administrative**VA State Inventory:** 114-0002-0220

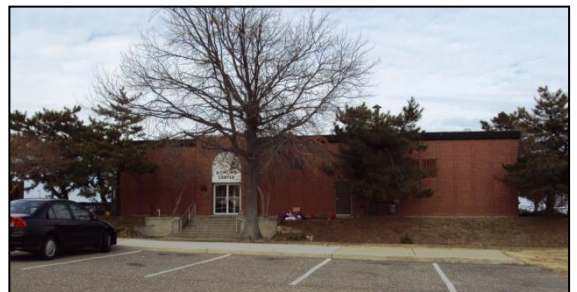
**Description:** Rectangular floor plan with a gabled and hipped roof. In 1986 a Porte Cochere was replaced by an arched canopy. There is a large exterior chimney on the front façade. The addition has three single pane fixed sash windows. First Floor: Six multi-paned, fixed-sash windows.**Materials:** Five course common bond brick walls built on a concrete foundation. Asphalt shingles on the roof. The arched canopy is wood on brick piers. Window sashes are aluminum and there are brick quoins around the front doorway. The addition has concrete coping at the roof line and a built up roof.**Mechanical/Electrical Systems:** This building has a dry fire suppression system. Electrical: Exterior transformers to an exterior disconnect switch and circuit breaker. Mechanical: Gas-fired water heater.**Building #: 201****Built:** 1969**Address:** 383 Fenwick Road**Dimensions:****Stories:** 1.0**NHL Status:** Non-contributing**Type:** Administrative (bowling alley)**VA State Inventory:** 114-0002-0278

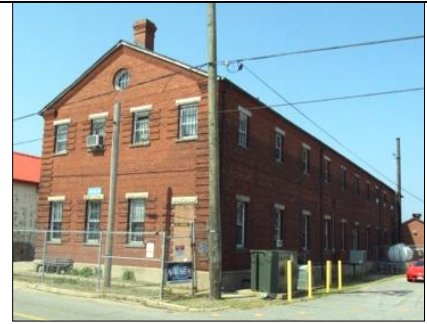
Building #: 204**Built:** 1910**Address:** 104 McNair Drive**Dimensions:** 33' 2" x 138' 3"**Stories:** 2.0**NHL Status:** Contributing**Type:** Administrative**VA State Inventory #:** 114-0002-0177

Description: Rectangular floor plan with a front facing gabled roof and a small gabled roof addition. Windows on both floors are six-over-six-light double-hung sash windows with lintels and sills. There are two central chimneys with corbelled caps, a round window at the gable end and a ranking cornice. **Interior:** Original stairs with railing; the upper floor has corridor with beaded wainscoting and chair rail molding.

Materials: Four course common bond brick walls; a concrete foundation and asphalt roof. Windows have granite lintels and stone sills. There are brick quoins and window surrounds; original wood stairs with steel pipe railings.

Mechanical/Electrical Systems: **Electrical:** Exterior transformers to an exterior disconnect switch and circuit breaker. **Mechanical:** Gas boiler and central AC system. Gas-fired water heater.

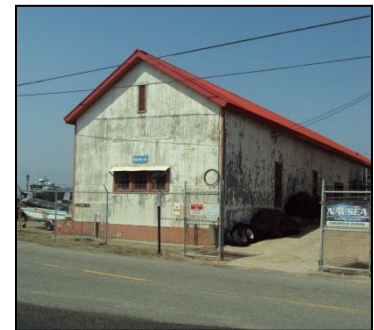
Building #: 205**Built:** 1910**Address:** 205 McNair Drive**Dimensions:** 148' 3" x 25' 11"**Stories:** 1.0**NHL Status:** Contributing**Type:** Administrative**VA State Inventory #:** 114-0002-0178

Description: Rectangular plan with a gabled roof, four-over-four light double hung sash windows and three six-light fixed windows.

Materials: Exterior walls are brick and corrugated metal exterior walls and roof, built on a concrete foundation.

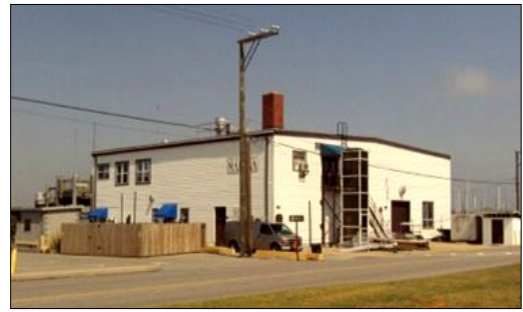
Building #: 207**Built:** 1943**Address:** 100 McNair Drive**Dimensions:** 75'1" (seven-bay front) x 83' 5"**Stories:** 2.0**NHL Status:** Non-contributing**Type:** Administrative**VA State Inventory #:** 114-0002-0225

Description: Rectangular floor plan with a built-up side gabled roof. **First Floor:** Wood panel doors and two-over-two light windows. **Second Floor:** One-over-one light double-hung sash windows and three-light windows with middle hopper window.

Materials: Wood frame with clapboard walls built on a wood pier foundation.

Mechanical/Electrical Systems: This building has a dry fire suppression system. **Electrical:** Exterior transformers to an exterior disconnect switch and circuit breaker. **Mechanical:** Possibly a heat pump.
