Table of Contents

Fort Monroe	Mothball Project	2011
4.3.2: Cast Iron (Brief 27)		27
4.3.3: Rust on Metal Roofing:		28
4.4: Roofs		28
4.4.1: Wood Shingles (Brief 19)		28
4.4.2: Asphalt Shingles		29
4.4.3: Slate Shingles (Brief 29)		29
4.4.4: Built Up Roofing System		30
4.4.5: Flashing		30
4.5: Lead Base Paint and Asbestos		31
4.5.1: Previous work		31
4.5.2: Regulations		31
4.5.3: Lead Base Paint		32
4.5.4: Asbestos		33

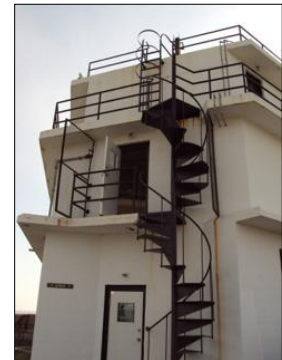
Building # 209**Built:** 1943**Address:** 148 Bernard Road**Dimensions:** N/A**Stories:** 3.0**NHL Status:** Contributing**Type:** Administrative**VA State Inventory #:** 114-0002-0179

Description: Irregular hexagon with a roof deck and flat tarpaper roof with an antenna mount. There is an exterior circular stairway on the northern façade providing access to the second and third floors. An engaged ladder gives access to the roof deck and there is railing surrounding the roof deck and third floor ledge. **First Floor:** Entry on northwest façade. There are four, six-light Hopper windows and three, three-light single transom windows. **Second Floor:** Entry identical to first floor; ribbon windows on five sides (eight windows in total). **Third Floor:** Entry on the southwest façade; ribbon windows on five sides.

Materials: Walls are poured concrete on a concrete foundation. Entries have glazed metal doors. The exterior stairway is steel, railings are metal.

Mechanical/Electrical Systems: **Electrical:** Unknown. **Mechanical:** One AC window unit.

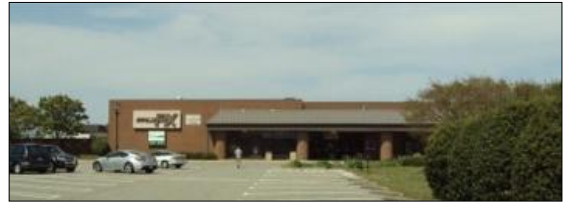
Building #: 210**Built:** 1985**Address:** 102 Griffith Street**Dimensions:****Stories:** 2.0**NHL Status:** Non-contributing**Type:** Administration**VA State Inventory #:** 114-0002-0279

Description: Rectangular floor plan with a side gabled roof and a loading dock on the west elevation.

Materials: Brick stretcher bond veneer walls built on a concrete foundation. The roof is flat with a standing seam metal roof at the south and west elevations supported by brick columns. There are no windows, only glass entrance doors.

Mechanical/Electrical Systems: This building has both a wet and dry fire suppression system. Electrical: Exterior transformers to an exterior disconnect switch and circuit breaker. Mechanical: Gas-fired water heater.

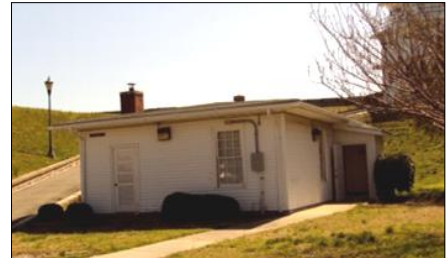
Building #: 217**Built:** 1921**Address:** 146 Bernard Road**Dimensions:** 52' 4" x 22' 9"**Stories:** 1.0**NHL Status:** Non-contributing**Type:** Administrative**VA State Inventory #:** 114-0002-0226

Description: Rectangular floor plan with a side ell, hipped roof, chimney stack and wide overhanging eaves. First Floor: Paneled door in side ell and nine-over-nine-light double-hung sash windows.

Materials: Wood frame, clapboards, a concrete foundation, an asphalt roof and exposed rafters.

Mechanical/Electrical Systems: Electrical: Exterior transformers to an exterior disconnect switch and circuit breaker. Mechanical: Oil boiler and central AC system. Gas-fired water heater.

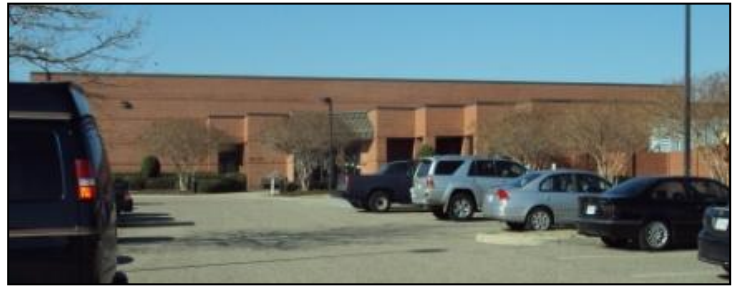
Building #: 221**Built:** 1998**Address:** 100 Stillwell Drive**Dimensions:****Stories:** 1.0**NHL Status:** Non-contributing**Type:** Administrative**VA State Inventory #:** 114-0002-0280

Description: Rectangular plan with an attached ell in the shape of a trapezoid with a stepped entrance. The main roof is flat with a hood roof over the main entrance. Windows are multi-light.

Materials: Stretcher bond brick walls with decorative brick at every half story, built on a concrete foundation. The hooded roof is standing metal seam and windows are metal.

Mechanical/Electrical Systems: This building has a dry fire suppression system. Needs to be site verified

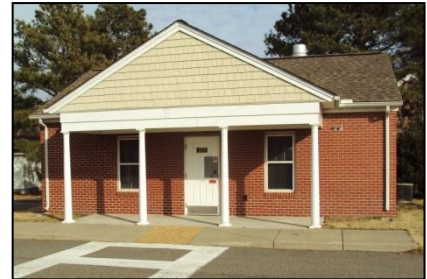
Building #: 225**Built:** 2003**Address:** McNair**Dimensions:****Stories:** 1.0**NHL Status:** Non-contributing**Type:** Administrative**VA State Inventory #:** 114-0002-0235

Description: Rectangular plan with a cross gable roof that extends beyond the structure to create a full story entry porch. The porch is supported by Doric columns and windows are two-over-two double-hung sash.

Materials: Running bond brick walls, a concrete foundation with an asphalt roof and wood shingles at the gables.

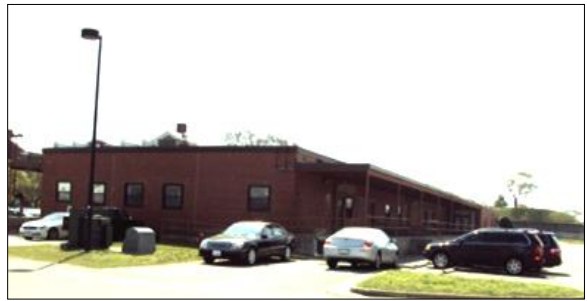
Building #: 243**Built:** 1952**Address:** 16 Murray Street**Dimensions:** 199' 6" (ten-bay front) x 54' 9"**Stories:** 1.0**NHL Status:** Non-contributing**Type:** Administrative**VA State Inventory #:** 114-0002-0246

Description: Rectangular floor plan, built-up roof and loading area along the façade. **First Floor:** Three glazed doors; two tractor-trailer loading doors; two large solid door and eighteen-light fixed sash windows with lintels.

Materials: Five course common bond brick walls. The foundation, loading area and lintels are concrete.

Mechanical/Electrical Systems: This building has a wet fire suppression system. Exterior transformers to an exterior disconnect switch and circuit breaker.

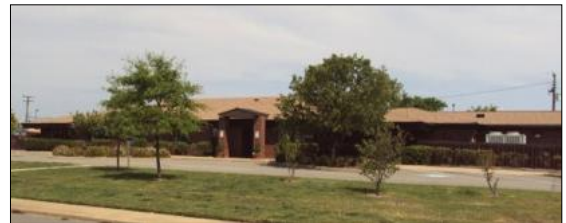
Building # 245**Built:** 1992**Address:** 370 Fenwick Road**Dimensions:****Stories:** 1.0**NHL Status:** Non-contributing**Type:** Administrative**VA State Inventory #:** 114-0002-0281

Description: Rectangular floor plan with a side ell on the south side, a Dutch gabled roof and overhanging eaves. The entrance has an overhanging gabled pediment supported by piers. Windows are two-light fixed.

Materials: Brick walls built on a concrete foundation, asphalt shingle roof and brick piers.

Mechanical/Electrical Systems: This building has a wet fire suppression system. **Electrical:** Exterior transformers to an exterior disconnect switch and circuit breaker; fire alarm. **Mechanical:** Gas boiler and central AC system. A sprinkler system and gas fired water heater.

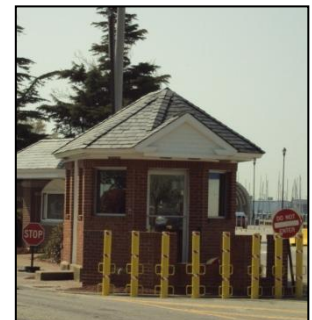
Building #: 560**Built:** 1968**Address:** Ingalls Road**Dimensions:** 13'5" x 10'0"**Stories:** 1.0**NHL Status:** Non-contributing**Type:** Administrative (Guard House)**VA State Inventory #:** 114-0002-0293

Description: A rectangular plan that is one story, a hipped roof that is pedimented on the north end with slate shingles. There are nine single paned windows and three glass doors.

Materials: A concrete foundation, with concrete steps, stretcher bond brick veneer walls and slate roof shingles.

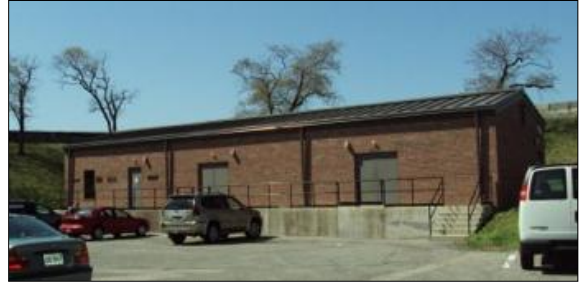
STORAGE**Building #: 8A****Built:** 2002**Address:** 12 Bernard Road**Dimensions:** 26' 0" x 77' 0"**Stories:** 1.0**NHL Status:** Non-contributing**Type:** Storage**VA State Inventory #:** 114-0002-0289

Description: Rectangular plan, gabled roof, loading area with two stairways, windows are one-over-one fixed.

Materials: Concrete walls, foundation, loading area and stairways. The roof is metal and doors are wood.

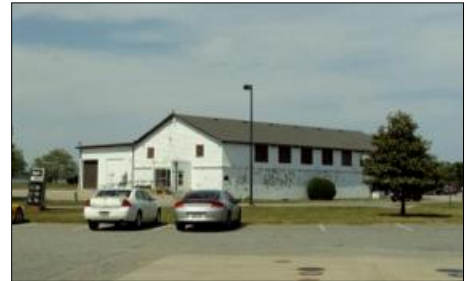
Description: Rectangular plan with projecting front vestibule; side and rear additions; a side gable, a shed roof and overhanging eaves with projecting boards. There is a detached chimney flue connected two feet above ground level. The addition has eight bays with buttresses, two garage sized openings and eight windows (seven have been filled in with cinder blocks). **First Floor:** Doorway in the projecting vestibule with automatic sliding doors. Two six-light fixed sash windows in the front-facing gable; double windows on the south side and six-over-six-light double-hung sash windows.

Materials: Poured concrete walls and foundation. The roof has asphalt shingles with a shed roof on the extension. The door in the vestibule is glass and aluminum. The addition is cinder block and has cinder block buttresses between the bays. The vestibule is also cinder block. There is concrete coping at the top of the first level

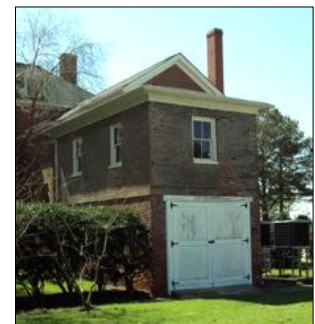
Description: Rectangular floor plan with a hipped roof and a belt course between floors. First Floor: Garage door. Second Floor: Two-over-two light windows with jack arches.

Materials: Five course common bond brick walls built on a concrete foundation. Asphalt roof.

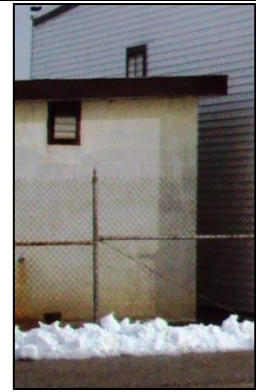
Building #: 72**Built:** 1982**Address:** 102 Eustis Road**Dimensions:****Stories:** 1.0**NHL Status:** Non-Contributing**Type:** Storage (workshop)**VA State Inventory #:** 114-0002-0197

Description: Rectangular floor plan with a shed roof. This building is on the north side of T-99.

Materials: Frame construction with vinyl siding built on a concrete foundation and rolled roofing.

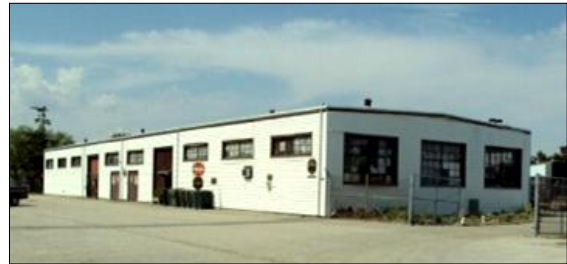
Building #: 81**Built:** 1943**Address:** 100 Eustis Lane**Dimensions:****Stories:** 1.0**NHL Status:** Non-contributing**Type:** Storage (warehouse)**VA State Inventory #:** 114-0002-0202

Description: Rectangular floor plan.

Material: Frame construction with vinyl siding built on a concrete foundation, with rolled roofing.

Mechanical/Electrical Systems: Electric heat and one AC unit in the office.

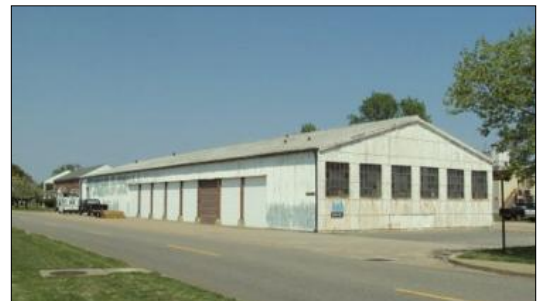
Building #: 88**Built:** 1934**Address:** 310 Fenwick Road**Dimensions:** 181' 0" (eight-bay front) x 57' 2"**Stories:** 1.0**NHL Status:** Non-contributing**Type:** Storage**VA State Inventory #:** 114-0002-0203

Description: Rectangular floor plan with a side gabled roof. First Floor: Overhead garage door with six garage bays closed with concrete till and fourteen-light fixed windows.

Materials: Steel frame with corrugated asbestos and metal siding built on a concrete foundation. The roof is corrugated-asbestos and doors are made of metal.

Mechanical/Electrical Systems: Electrical: Exterior transformers to an exterior disconnect switch and circuit breaker. Mechanical: Gas-fired water heater.

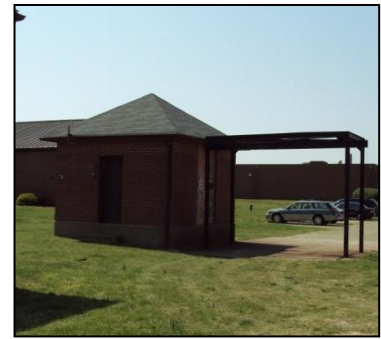
Building #: 91**Built:** 1934**Address:** 186 New Garden Street**Dimensions:** 14' 6" (one-bay front) x 14' 6"**Stories:** 1.0**NHL Status:** Non-contributing**Type:** Storage**VA State Inventory #:** 114-0002-0205

Description: Prefabricated with a rectangular floor plan. The main door has a one-light.

Materials: Stretcher bond brick veneer walls built on a concrete foundation with an asphalt shingle pyramidal roof. The door is metal; there is a concrete water table and concrete steps.

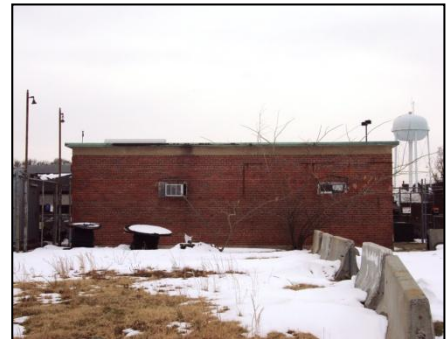
Building #: 104**Built:** 1949**Address:** Patch Road**Dimensions:** 16' 0" (one-bay front) x 40' 7"**Stories:** 1.0**NHL Status:** Non-contributing**Type:** Storage (energy)**VA State Inventory #:** 114-0002-0208

Description: Rectangular plan with a built-up roof. First Floor: Glazed door with louvers.

Materials: Five course common bond brick walls built on a concrete foundation. Main door is metal.

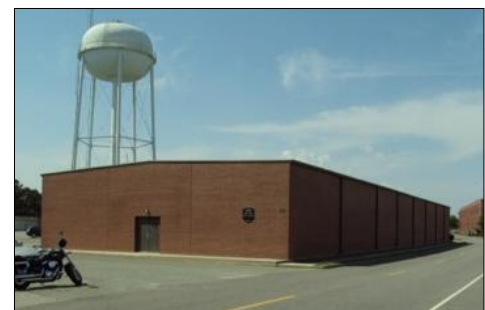
Building #: 168**Built:** After 1990**Address:** 12 Murray Street**Dimensions:****Stories:** 1.0**NHL Status:** Non-contributing**Type:** Storage (warehouse)**VA State Inventory #:** 114-0002-0214

Description: Rectangular floor plan with two additions (north and west elevations) and a gabled roof. There is a concrete loading area, two large garage doors and a standard door and a 500 gallon heating oil tank.

Building: Five course common bond brick walls built on a concrete foundation. Asphalt shingles.

Mechanical/Electrical Systems: This building has a dry fire suppression system. Electrical: Exterior transformers to an exterior disconnect switch and circuit breaker. Mechanical: Oil boiler, heat pump and central AC system. Gas-fired water heater.

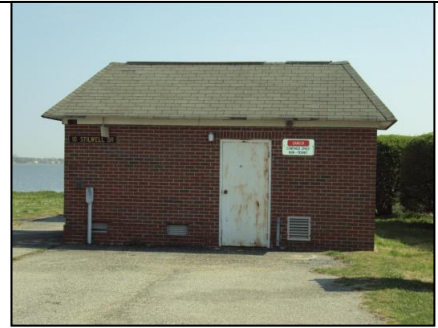
Building #: 172**Built:** 1934**Address:** 10 Stillwell Drive**Dimensions:****Stories:** 1.0**NHL Status:** Non-Contributing**Type:** Storage**VA State Inventory #:** 114-0002-0216

Description: Square floor plan with a hipped roof and one door. This building houses the main water valve for the fort.

Materials: Stretcher bond brick veneer walls built on a concrete foundation, asphalt roof and a metal door.

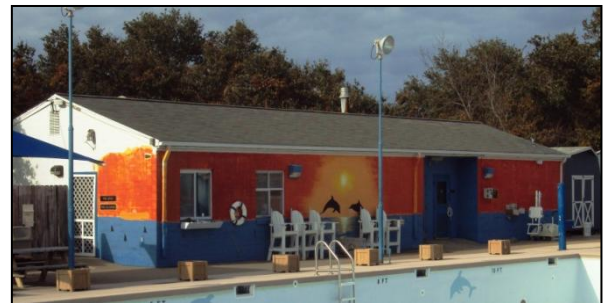
Building #: 190**Built:** 1988**Address:** 190 Rose Circle**Dimensions:****Stories:** 1.0**NHL Status:** Non-contributing**Type:** Storage (garage)**VA State Inventory #:** 114-0002-0277

Description: Rectangular floor plan, side gabled roof and two sliding concession windows.

Materials: Concrete block building built on a concrete foundation with asphalt roof shingles.

Mechanical/Electrical Systems: Electrical: Exterior transformers to an exterior disconnect switch and circuit breaker. Mechanical: Central AC system and one AC window unit. Gas-fired water heater.

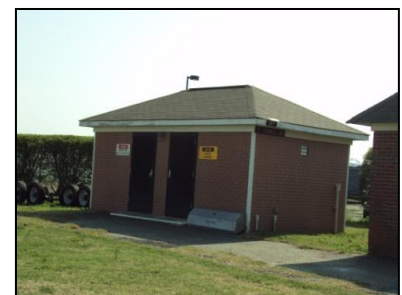
Building #: 197**Built:** 1996**Address:** 12 Stilwell Drive**Dimensions:** 12'0" x 20'0"**Stories:** 1**NHL Status:** Non-contributing**Type:** Storage**VA State Inventory #:** 114-0002-0291

Description: A small square plan that is one story, with a hipped roof and two side by side metal doors.

Materials: Concrete foundation with brick veneer walls, asphalt roof shingles.

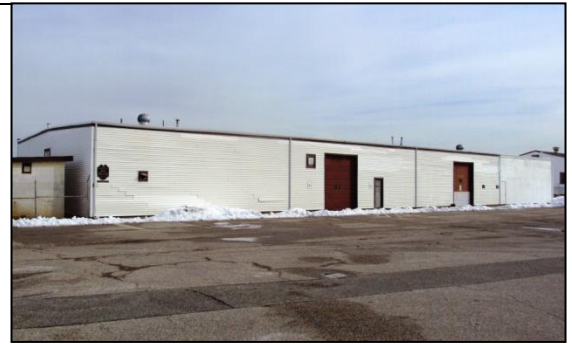
Description: Rectangular floor plan with a gabled roof, an entry door and overhead garage doors.

Materials: Wood frame, vinyl siding, concrete foundation, asphalt roof shingles and metal doors.

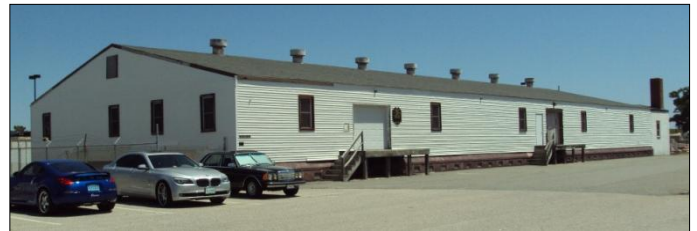
Description: Rectangular floor plan with a gabled roof.

Materials: Building T-104 has a wet fire suppression system. Wood frame with vinyl siding, a concrete foundation and asphalt roof shingles. The building has an aluminum frame glass doors; metal and wood doors; overhead garage doors and six-over-six-light double-hung sash windows.

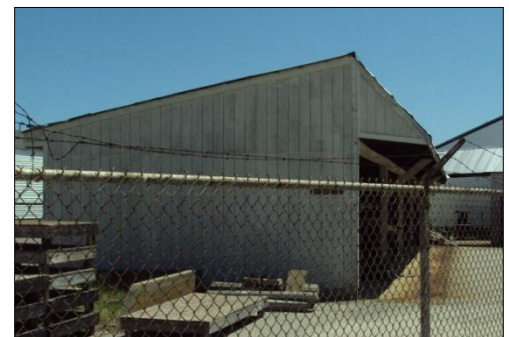
Description: Rectangular floor plan and standing roof.

Building: Wood frame and siding built on a concrete foundation with a standing-seam metal roof.

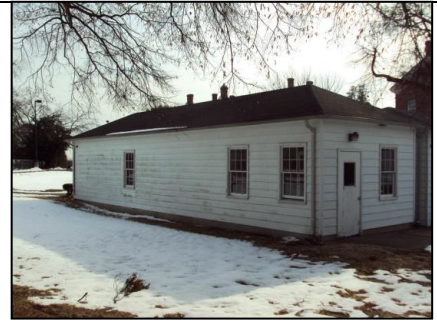
Building #: T-216, T-457 and T-468**Built:** 1954 and 1957**Address:** Fenwick Road**Dimensions:** 49' 2" (two-bay front) x 14' 4" (T-216) and 23' 4" (two-bay front) x 22' 7"**Stories:** 1.0**NHL Status:** Non-contributing**Type:** Storage (workshop)**VA State Inventory #:**

Description: Rectangular floor plan with a hipped roof. All buildings have an overhang garage door. T-216: Glazed door and six-over-six-light double-hung sash windows.

Building: Wood frame and siding built on a concrete foundation with an asphalt roof and metal garage doors. T-216: Wood door.

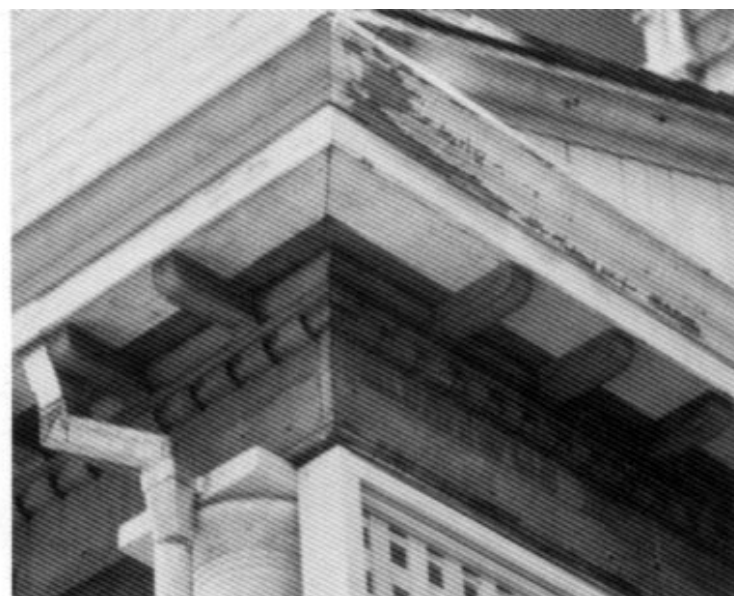
Two examples of “limited replacement in kind” point out an appropriate scope of work within the treatment, Preservation. (a) One metal modillion that has sustained damage from a faulty gutter will need to be replaced; and (b) targeted repairs to deteriorated wood cornice elements (fascia board and modillions) meant that most of the historic materials were retained in the work.

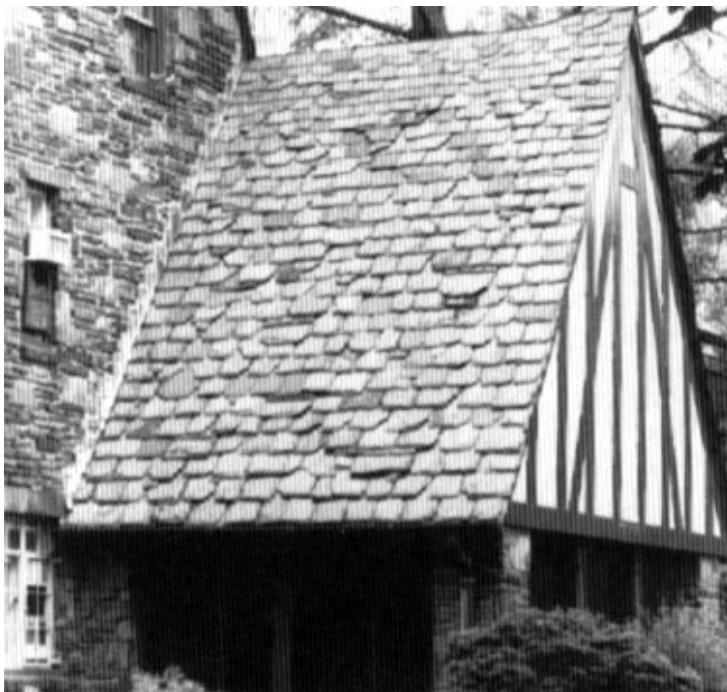
It is particularly important to preserve materials that contribute to a building's historic character, such as this highly visible slate roof. In the event that repair and limited replacement are necessary, all new slate would need to match the old exactly. Photo: Jeffrey S. Levine.

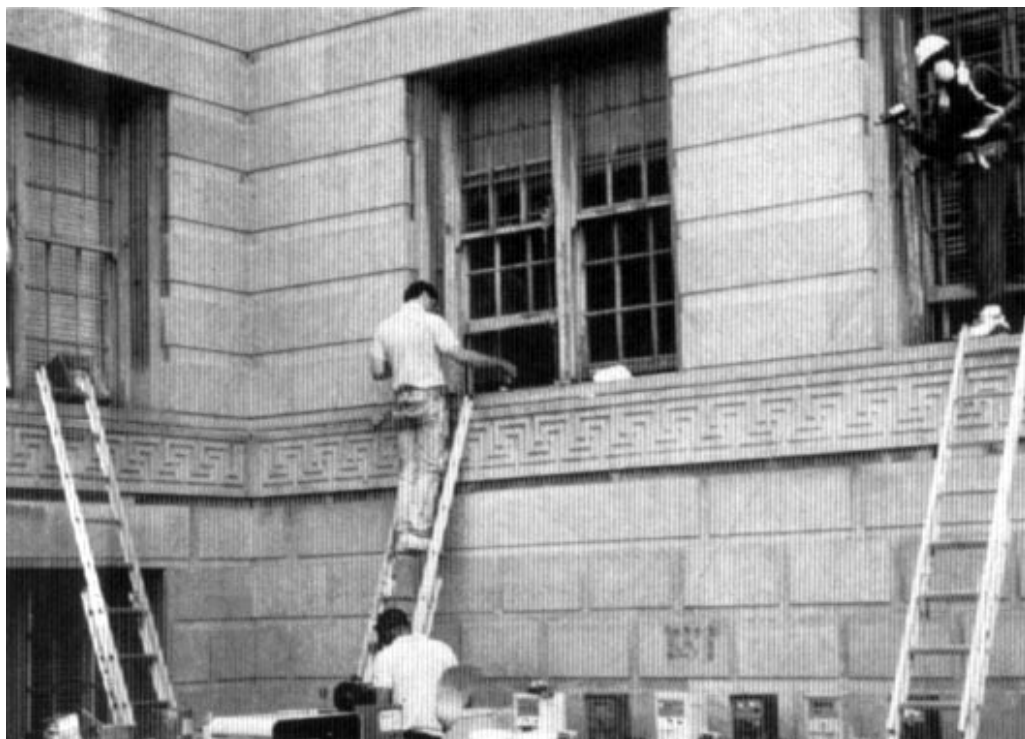
Preserving a building's historic windows generally involves scraping, sanding, and re-painting. While some repair work will most likely be undertaken within the scope of work on this institutional building, replacement of the window units is usually not an appropriate Preservation treatment. Photo: Chuck Fisher.

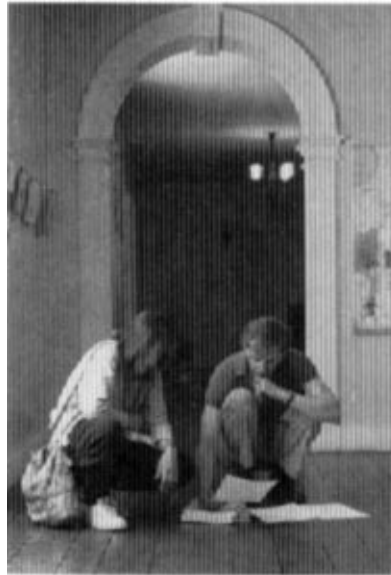
Careful documentation of a building's physical condition is the critical first step in determining an appropriate level of intervention. (a) This may include relating the historical research to existing materials and features; or (b) documenting a particular problem such as this cracked ceiling. Photo (a): Jean E. Travers; Photo (b): Lee H. Nelson, FAIA.

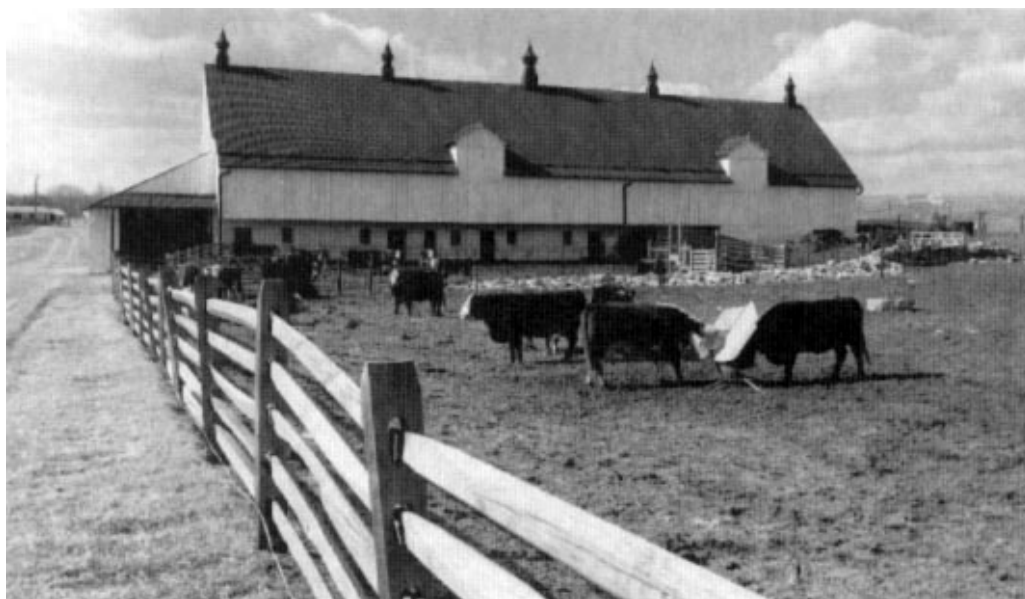
The goal of Preservation is to retain the historic form, materials, and features of the building and its site as they have changed—or evolved—over time. This bank barn was built in the 1820s, then enlarged in 1898 and again in 1914. Today, it continues its role as a working farm structure as a result of sensitive preservation work. This included foundation re-grading; a new gutter system; structural strengthening; and replacement of a severely deteriorated metal roof. Photo: Jack E. Boucher, HABS.

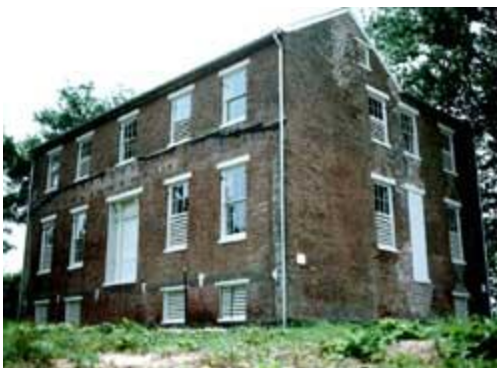
This building has been successfully mothballed for 10 years because the roof and walls were repaired and structurally stabilized, ventilation louvers added, and the property maintained. Photo: NPS files.

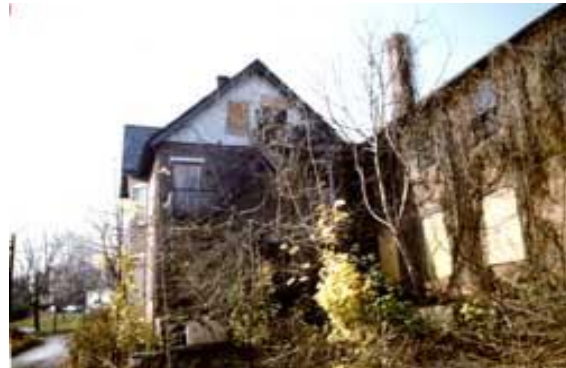
Boarding up without adequate ventilation and maintenance has accelerated deterioration of this property. Photo: NPS files.

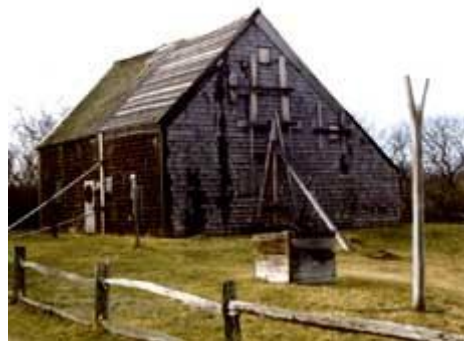
Buildings seriously damaged by storms or deterioration may need to be braced before architectural evaluations can be made. Photo: John Milner Architects. Photo: NPS files

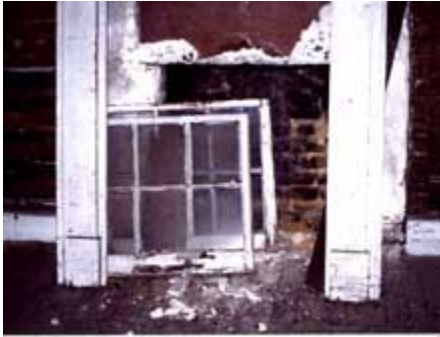
Loose or detached elements should be identified, tagged and stored, preferably on site. Photo: NPS files

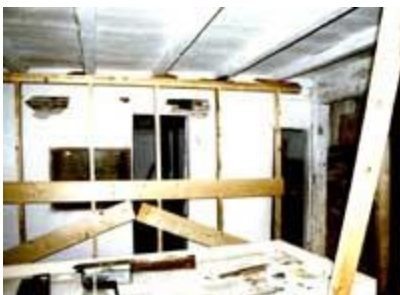
Interior bracing which will last the duration of the mothballing will protect weakened structural members. Photo: John Milner Architects.

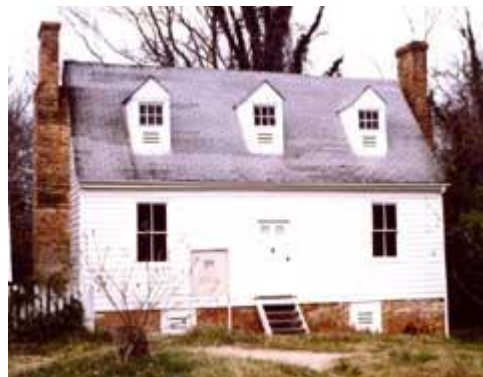
Regrading has protected this masonry foundation wall from excessive damp during its 10-year mothballing. Note the attic and basement vents, temporary stairs, and interpretive sign. Photo: NPS files.

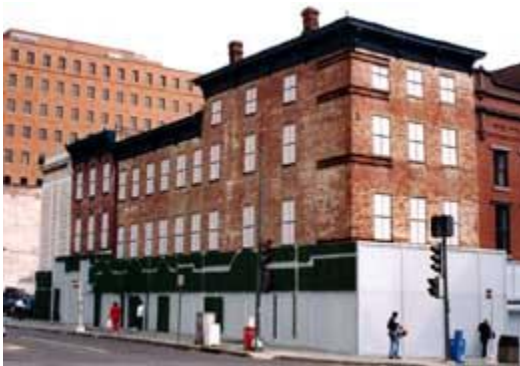
Urban buildings often need additional protection from unwanted entry and graffiti. This commercial building uses painted plywood panels to cover its glass storefronts. The upper windows on the street sides have been painted to resemble 19th century sash. Photo: NPS files.

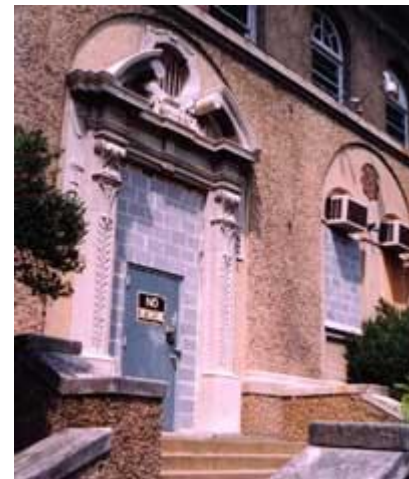
The first floor openings of this historic building have been filled with cinder blocks and the doors, window sash, and frames removed for safe keeping. The security metal door features heavy duty locks. Photo: NPS files.

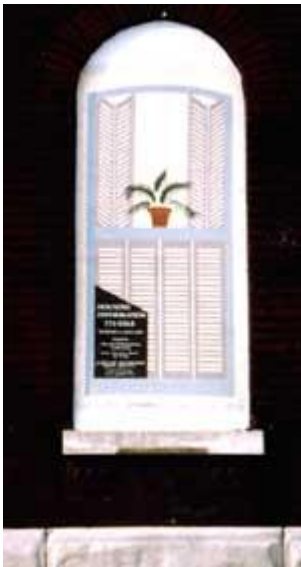
This painted trompe l'oeil scene on plywood panels is a neighborhood-friendly device. Photo: NPS files.

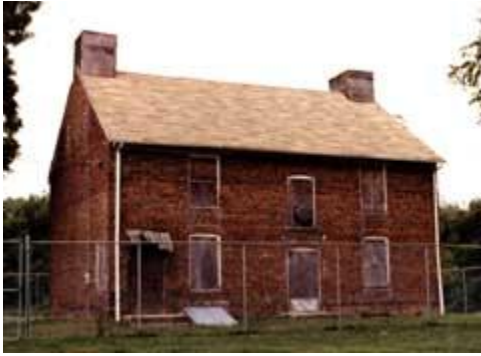
A view showing the exterior of the Brearley House, New Jersey, in its mothballed condition Photo: Michael Mills, Ford Farewell Mills Gatsch, Architects.

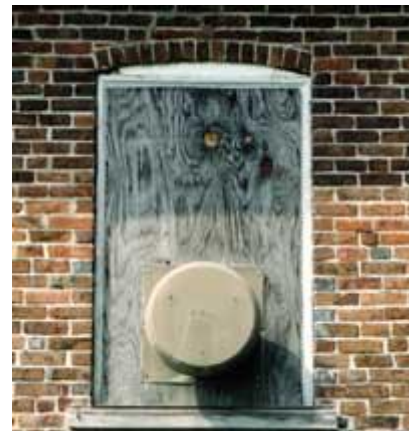
This exhaust fan has tamper-proof housing. Photo: Michael Mills, Ford Farewell Mills Gatsch, Architects.

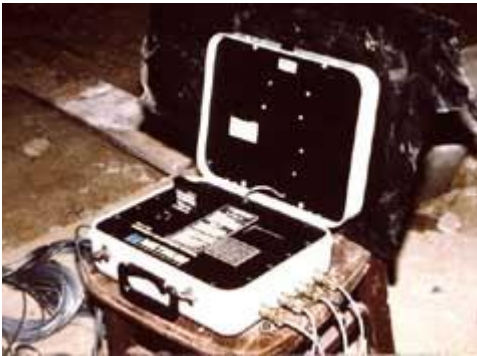
Portable monitors are used to record temperature and humidity conditions in historic buildings during mothballing. Photo: NPS files.

Monitoring devices which can record internal temperature and humidity levels can be invaluable in determining if the internal climate is remaining stable. These units can be powered by portable battery packs or can be wired into electric service with data downloaded into laptop computers periodically. This can also give long-term information throughout the mothballing years. If it is determined that there are inadequate air exchanges to keep interior moisture levels under control, additional passive ventilation can be increased, or, if there is electric service, mechanical exhaust fans can be installed. One fan in a small to medium sized building can reduce the amount of louvering substantially.
